Study on Monitoring Methods of Stone Cultural Relics -Taking Shaoxing Yangshan Statue as an Example

Yu Zhiming¹ Zhao Xiaowei² He Fei² Yang Ping^{3*} 1.Shaoxing Keqiao Museum, Shaoxing 312030, China; 2.Hangzhou biaodian surveying and Mapping Technology Co., Ltd.Hangzhou 310005, China 3.Zhejiang University of Science and Technology, Hangzhou 310023, China

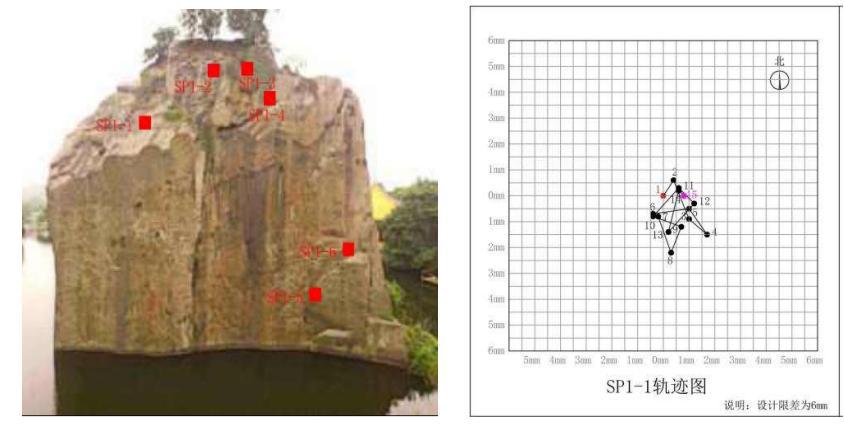
Chart1 NO.1Schematic diagram of monitoring point of horizontal displacement of rock mass

Chart 2 NO.1 Horizontal displacement track diagram of rock mass SP1-1 point

The horizontal displacement monitoring data were collected 15 times from October 26, 2019 to April 23, 2021, and the maximum single change of horizontal displacement of four rock masses was 2.4mm. The accumulative horizontal displacement of I, II and III dangerous rock mass is less than 3.4mm, and the accumulative horizontal displacement of Iv rock is 4.6mm, which requires further observation but is less than the design accuracy limit ± 6.0 mm. The horizontal displacement track chart shows irregular changes (taking the sp1-1 point of no. I dangerous rock mass as an example, as shown in Figure 2). It can be considered that the horizontal displacement of observation points has no change or no significant change in all observation periods.

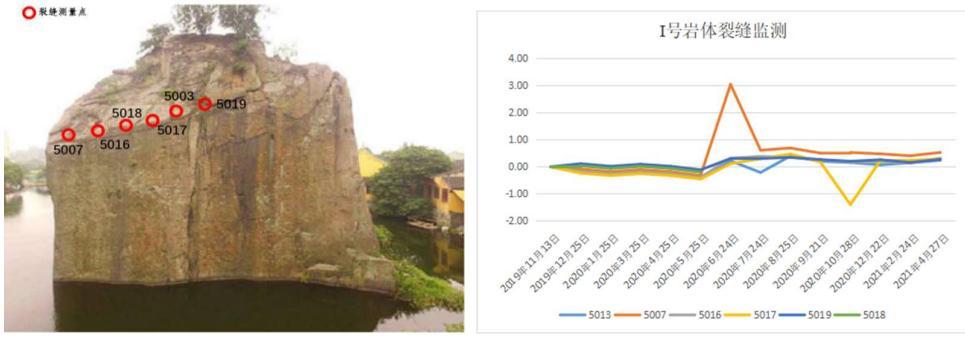
Chart3.NO.1Schematic diagram of rock fracture sensor layout

Chart3.NO.1Change diagram of fracture monitoring data of dangerous rock mass

Data were collected from November 13, 2019. The 6 fracture sensors of No. i rock mass varied from 0.24 mm to 0.53mm, the 3 fracture sensors of No. II rock mass varied from 1.15 mm to 0.12mm, and the 5 fracture

sensors of No. III rock mass varied from -0.17 mm to 0.4mm. The variation of 6 fracture sensors in No.Iv rock mass is -0.28-0.66mm. During the monitoring period, the monitoring data has a small fluctuation value and a relatively consistent trend, which meets the requirements of the design value. Take the change of crack sensor in No. I dangerous rock mass as an example, as shown in FIG. 4).

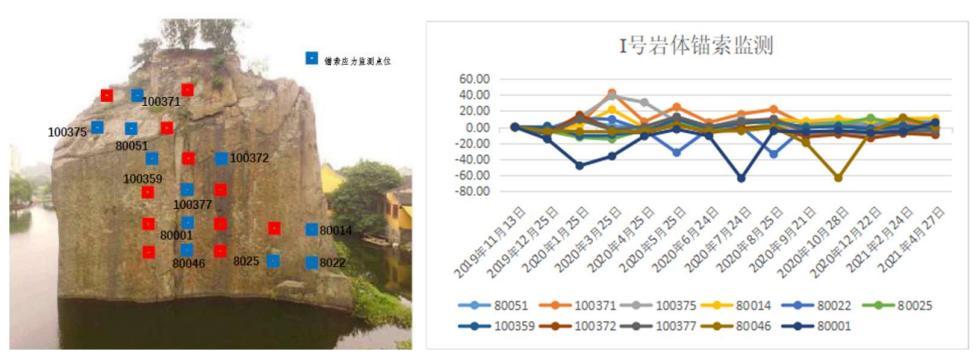
Chart 5 NO.1 Rock anchoring dynamometer layout point map

The data were collected from November 13, 2019. The stress variation of anchor cable in No. I rock mass is between-9.89--10.5kN, that of anchor cable in No. II rock mass is between -28.52KN--5.89kN, that of anchor cable in No. III rock mass is between -5.91-16.79kN. The stress variation of anchor cable in No. Iv rock mass is between -8.07 and 15.04KN. According to the above data, it can be seen that the sensor data variation of anchor cable in No.I, II, III and Iv rock mass is small, and the values are all small within the range of design control values, meeting the requirements of design values. Take the stress change of anchor cable in No. I dangerous rock mass as an example, as shown in FIG. 6).

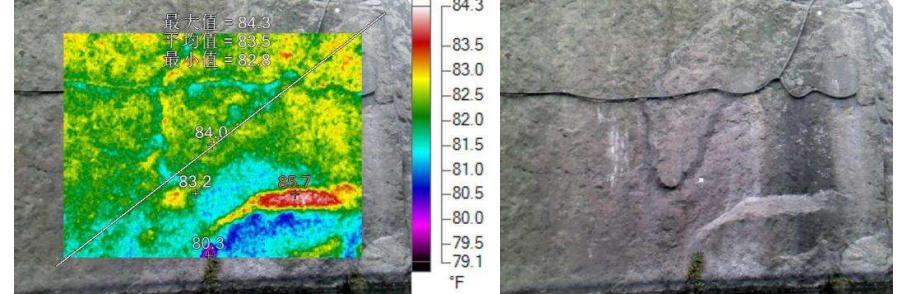
Chart 6 Infrared thermal image of the stone carving at position J1-5

The uniform density of fissure repair and reinforcement material was detected by temperature distribution of infrared thermal imaging. Two crack grouting sites were selected for monitoring. The temperature at grouting before spraying water is higher than that at rock surface, indicating that the heat absorption of grouting material is higher than that of rock. Measured five minutes after spraying, the temperature at the grouting place and rock surface basically returned to before spraying, indicating that water does not stay in the material for a long time, the material has good internal water permeability, and the material itself is relatively uniform and compact.

According to the infrared thermal imaging picture (as shown in FIG. 6), it can be seen that the temperature is basically uniform and there is no obvious fault. It shows that the bonding property of grouting reinforcement material is very good, and there is no phenomenon of loosening and disconnecting.
