## Sulfate attack - Reaction mechanisms revealed by a multi proxy approach

**Abstract.** The destructive effects of sulfate attack on concrete structures are well known, but the reaction paths and mechanisms that cause the deterioration are still under debate. The aim of this study is to contribute to a deeper understanding on investigating concrete damage by introducing a novel and promising multi proxy approach method. The methodology comprises advanced mineralogical and hydro-geochemical methods as well as stable isotope signals. Investigations were performed on various field case studies in Austria, where the locally occurring ground water was classified as slightly aggressive to concrete, in accordance to DIN EN 206-1. Nevertheless intense concrete damage related to sulfate attack was found. Severely damaged mushy concrete consisted mainly of thaumasite, secondary calcite, gypsum and relicts of aggregate. The expressed interstitial solutions from such material were extremely enriched in  $\text{SO}_4$  (up to  $>30000 \text{ mg L}^{-1}$ ). Stable hydrogen and oxygen isotope were applied successfully and demonstrated that the degree of evaporation provoked enrichments in  $\te

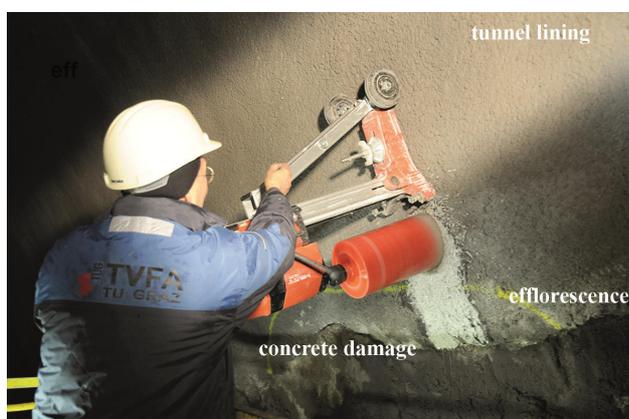
In Figure 1 a sampling site in a railroad tunnel is displayed, showing heavily deteriorated concrete. Intense alteration at the border of the old brick wall lining (early 1900) and on the surrounding shotcrete that was installed in the 1960ies had caused large areas of the shotcrete to fall off, resulting in endangering the traffic that passes through the tunnel.

**Fig. 1.** Sample taking at a damaged tunnel shotcrete lining. The drill core is taken above an area, where the shotcrete lining has been fallen off. White needle-like efflorescence is present at the transition between the damage area and superficial sound shotcrete.

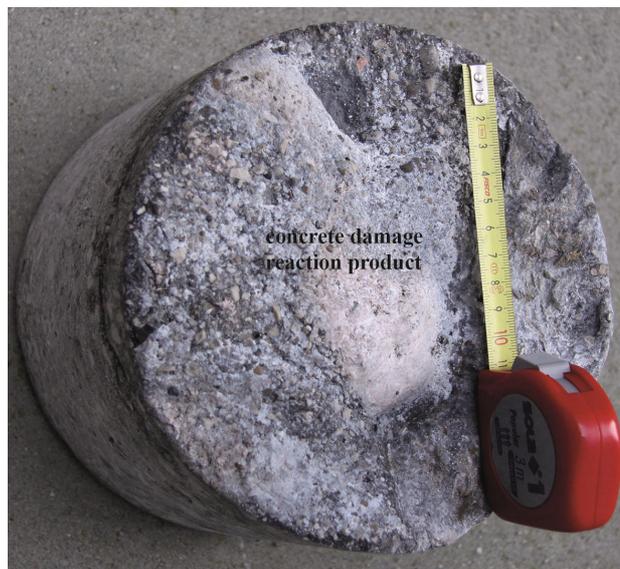
**Fig. 2.** Alteration products at the border between the old brick wall lining and the shotcrete.

In general, the collected solid samples are comprised of shotcrete and concrete, either unaltered or deteriorated. Completely disintegrated mushy material was shoveled into plastic bags, while concrete samples with a more stable appearance were excavated by taking 20 cm drilling cores (Figure 2). Furthermore, samples that show intense alterations such as efflorescence were carefully brushed from the tunnel walls and stored in air-tight containers.

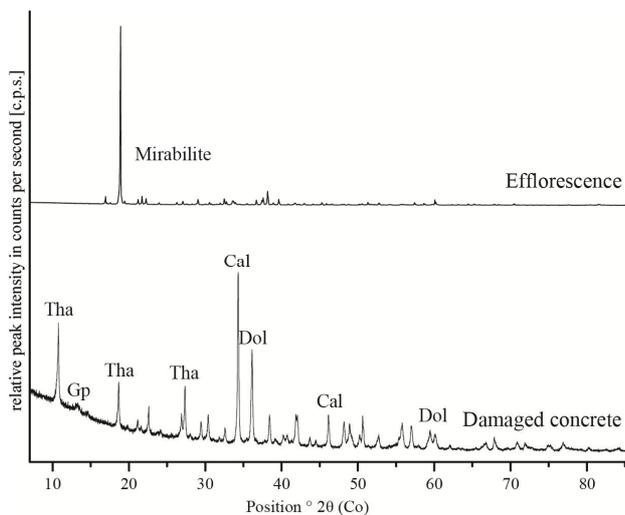
portlandite as well as silicate and carbonate aggregates like quartz, feldspar, dolomite and calcite. Mineralogical investigations (XRD, EPMA, and SEM) of the severely damaged concrete clearly showed that the deterioration was caused by sulfate attack, because the completely disintegrated materials consisted mainly of thaumasite, calcite and silicate aggregates (Figure 3) [14]. Gypsum was detected in small quantities, whereas ettringite was not found. Furthermore, a significant reduction or even a total lacking of dolomite aggregates was detected by comparison of unaltered and deteriorated material.

**Fig. 3.** XRD pattern. The needle-like efflorescence identified as mirabilite, a sodium sulfate hydrate mineral. In contrast, the damaged mushy concrete consisted mainly of thaumasite (Tha), calcite (Cal) and dolomite (Dol), among small amounts of gypsum (Gp). Modified after Mittermayr et al. [14].

However, the effect of evaporation on TSA has not yet been proven and was by far not quantified in such a scenario. Therefore we analyzed the chemical and isotopic composition of ground and drainage water as well as of the interstitial solutions that were extracted from heavily damaged concrete samples. In these samples the extracted solutions accounted for about 5 up to 20 wt.% of the solids. In these aqueous solutions extreme accumulations of sodium and sulfate were observed. While the Na content ranged between  $0.2 - 4.0 \text{ mg L}^{-1}$  in the ground water, it reached  $>17000 \text{ mg L}^{-1}$  in some of the expressed interstitial solutions [14].  $\text{SO}_4$  concentrations therein rose up to  $>30000 \text{ mg L}^{-1}$ . An extreme and linear enrichment of univalent cations (e.g. K and Rb) with a conservative behavior in the expressed solutions suggested evaporation of water to have caused the extreme contents in the interstitial solutions. A further indication for highly concentrated sodium sulfate interstitial solutions is the existence of mirabilite ( $\text{Na}_2\text{SO}_4 \cdot 10\text{H}_2\text{O}$ ) in the efflorescence, as identified by XRD (Figure 3).

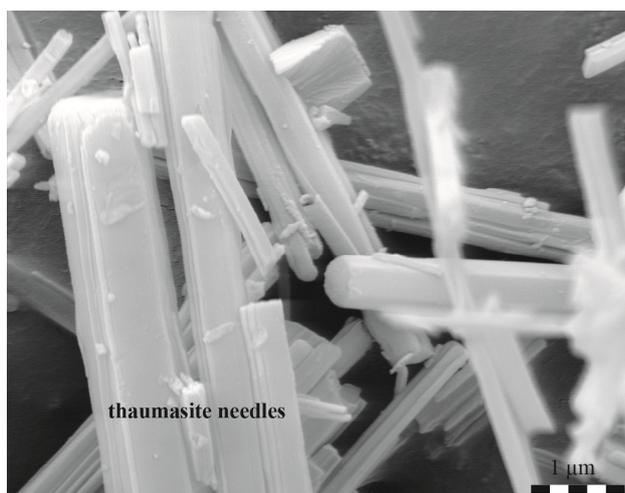
**Fig. 4.** The SEI of intensely damaged concrete displays plenty of thaumasite needles.

Consequently, the intense concrete damage is considered to be attributed to TSA. As TSA is known to occur preferentially in highly sulfate loaded environments, high amounts of dissolved sulfate were expected in the local ground water [16, 17]. Surprisingly, the ground water and the drainage water analyses generally revealed low to

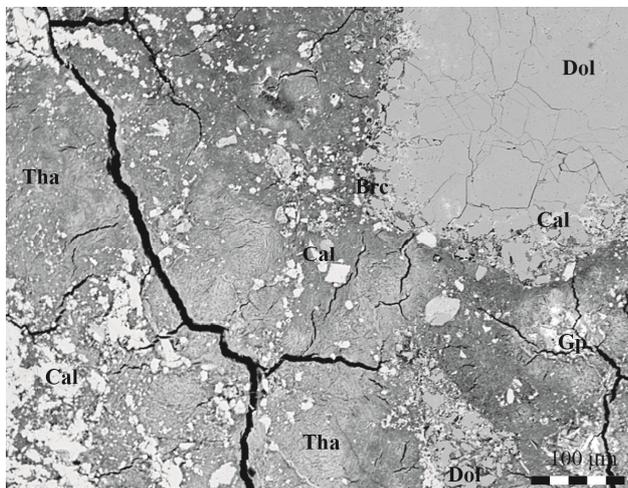
A further curiosity with a high need to be investigated was the incongruent dissolution of dolomite aggregates (Figure 5). In spite of being a well-known reaction for deteriorating concrete, it has not gained much attention in scientific research. The so-called alkali carbonate reaction (ACR) comprises the dissolution of dolomite at alkaline conditions in concrete [22]. Previously we have suggested that dolomite aggregates were preferentially dissolving incongruently governed by high Ca/Mg ratios in the interacting aqueous solution or interstitial solutions [23]. For the investigated cases, calcite was surprisingly more stable than dolomite, because as long as the pH remained above 10.5 the continuous leaching of Mg from the dolomite in the presence of interstitial solutions has

led to the formation of brucite ( $\text{Mg}(\text{OH})_2$ ), which speeded up the breakdown of the dolomite. One typical example of sulfate attack in combination with the progressing alteration of dolomite aggregates is illustrated in Figure 5, where incongruent dissolution of dolomite takes place simultaneously with the formation of secondary calcite and brucite.

**Fig. 5.** BSE image of a polished damaged concrete sample. The cementitious matrix has been completely replaced by thaumasite (Tha), secondary calcite (Cal) and small amounts of gypsum (Gp). The dolomite (Dol) aggregates show incongruent dissolution features, as evident by the occurrence of marginal calcite and brucite (Brc) as alteration products.
