Performance, Problems and Remedial Measures for Roads Constructed on Expansive Soil in Ethiopia – A Review

Bantayehu Uba Uge

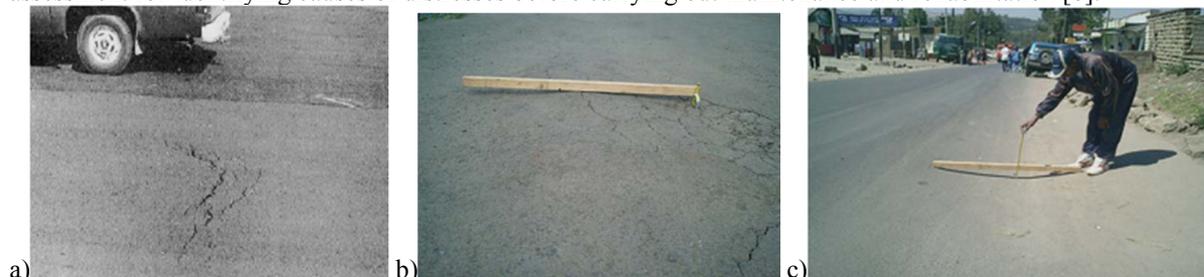
Figure 1(a) Slippage cracks, (b) Swelling- upward displacement of a pavement, c) Sag in asphalt pavement [12]

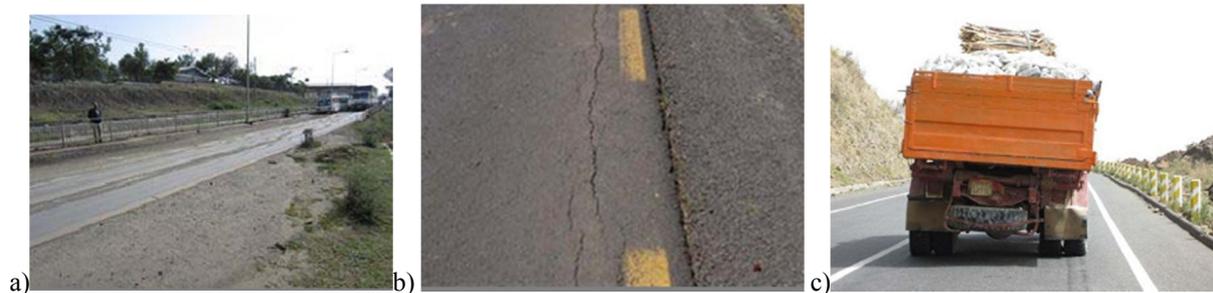
Figure 2 (a) Urban trunk road under the influence of black cotton soil, Rutting occurred on the surface. (b) Rural trunk road - Vertical rutting of pavement edge. (c) Heavy vehicles hauling lime-stone have been passing in Abay. Travelling speed is lower than walking speed. [15]

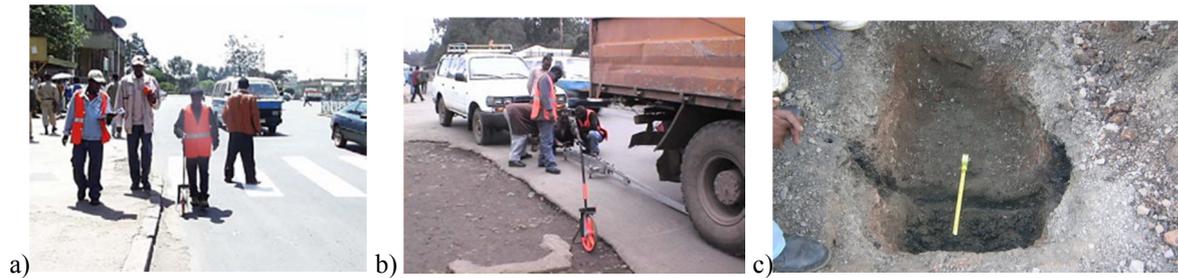
Figure 3 (a) and (b) Visual Condition Surveys [12]; (c) Test pit on Addis - Jimma Road [5]

The visual Condition survey was also made by Fikir [12] in order to measure various types and degrees or severity of distress. The measured components are surface defects (such as longitudinal joint cracks, potholes, raveling, bleeding and lacy edge), permanent deformation or distortion, fatigue cracking and patch deterioration. Walking along the Test Road section, distresses were measured using proper parameters such as fatigue cracking (sq.mt), bleeding (sq.mt), corrugation (sq.mt), depression (sq.mt), longitudinal and transverse cracking (linear mt), patch deterioration (sq.mt), potholes (number), raveling and weathering (sq.mt), rutting (sq.mt), slippage cracking (sq.mt), and swell (sq.mt) with the help of measuring wheel, measuring tape and camera (Figure 3). The Pavement Condition Index (PCI) is determined by measuring pavement distress with a numerical indicator based on a scale of 0 to 100. The following pavement condition ranking is given to PCI values: 0-10(failed); 10-25(very poor); 25-40(poor); 40-55(fair); 55-70(good); 70-85(very good); 85-100(excellent). Large deflection, low PCI values and consequently higher distress densities are observed in test sections having high swell potential. This indicates that the swell potential of the sub grade soil has significant impact on the pavement functional and structural conditions.

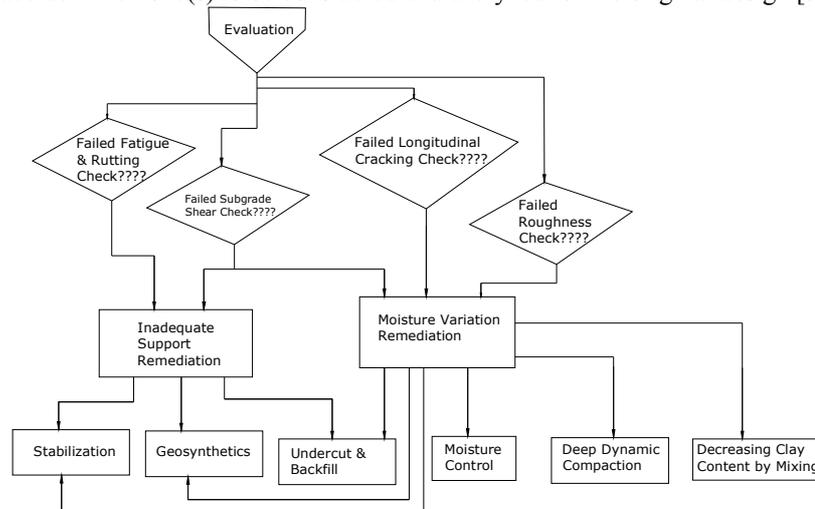
Figure 1 Schematic of Remediation Strategies [32]

Expansive soils exhibit exceptionally low strength and tend to swell when they become wet; and they are highly brittle and shrink when they become dry. Their susceptibility to moisture variation results in two main types of damage through seasonal wet and dry cycles: (1) Fatigue cracking, rutting and subgrade shear failure due to inadequate support; (2) Excessive roughness, swelling and severe longitudinal shrinkage cracking due to volume change. Many remediation strategies can be used to improve the detrimental properties of expansive soils, such as shrink-swell and low shear strength. In the Remediation module, six modification strategies are grouped into two categories: (1) To improve subgrade strength and stiffness, which include stabilization, geosynthetics reinforcement, undercut and backfill; and (2) To minimize moisture variation induced swell/shrink problems, which include moisture control, deep dynamic compaction and decreasing clay content in addition to those three included in category 1. Appropriate methods will be recommended from either or both categories (Figure 1). The user has the choice to decide which one(s) to be considered and analyzed for the original design [32].
