Bad Drainage and Its Effects on Road Pavement Conditions in Nigeria

Agbonkhese Onoyan-usina* Yisa Godwin Lazhi Daudu Paul Itomi-ushi
Nigerian Building and Road Research Institute, National Laboratory Complex. Kilometer10, Idiroko road, Ota,
Ogun state, Nigeria

This paper discusses the various effects of bad drainage on road pavement conditions in Nigeria. A lot of Nigerian roads across the country have inadequate drainage systems and deterioration often begins with the origin of cracks or pot holes on the road pavements either at the edges or along the drive way. This investigation looks into major Nigerian highways like the Lagos-Badagry expressway and municipal roads like the Siluko-Ring Road, Benin, Edo State. Having identified these two roads as case studies, on-site assessment of both roads were scheduled and visited with a view of investigating the possible causes of drainage deterioration and its subsequent effects on road pavement conditions. With the aid of a camera, pictures of the various degrees of drainage deterioration and its consequent effects on road pavement conditions were taken and labeled figures 1 to 11. Based on this investigation, it was discovered that ad

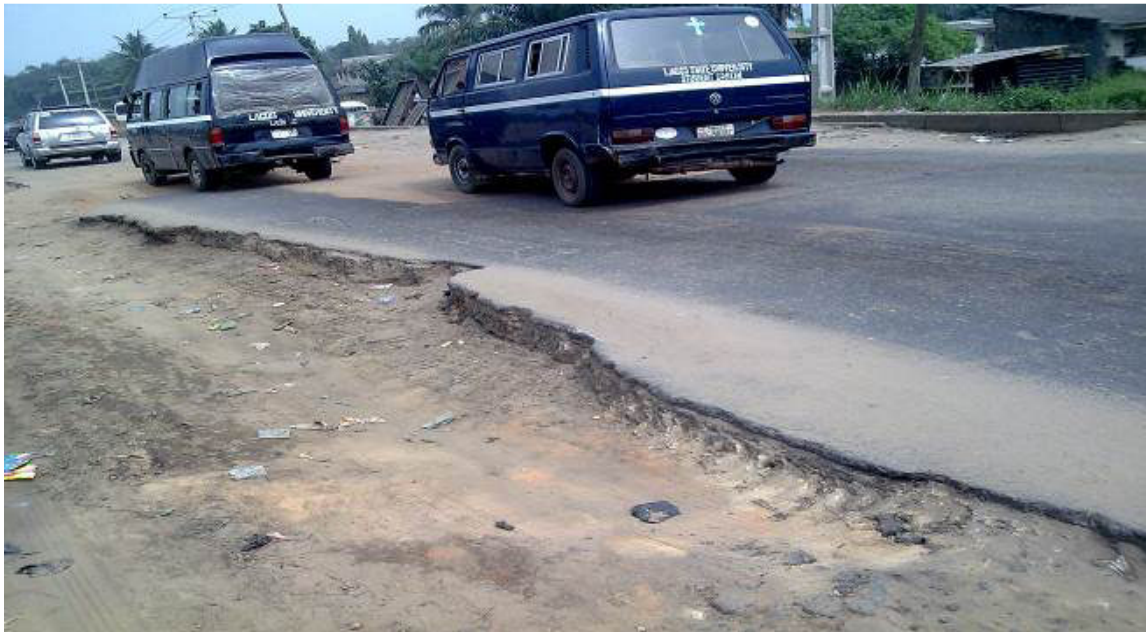
On a lot of Nigerian roads across the country having inadequate drainage systems, deterioration often begins with the origin of cracks or pot holes on the road pavements either at the edges (Figure 1) or along the drive way (Figure 2) which differs by their shapes, configuration, amplitude of loading, movement of traffic and rate of deformation.

Figure 1. Edge Failure.

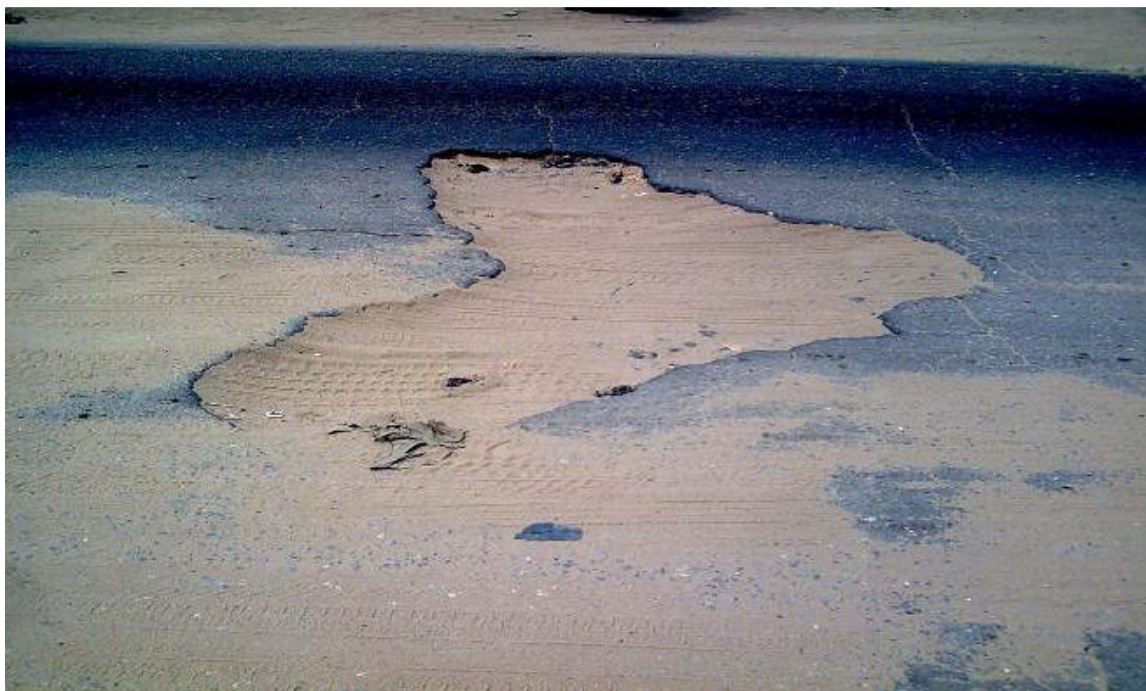
Figure 2. Pot Hole.

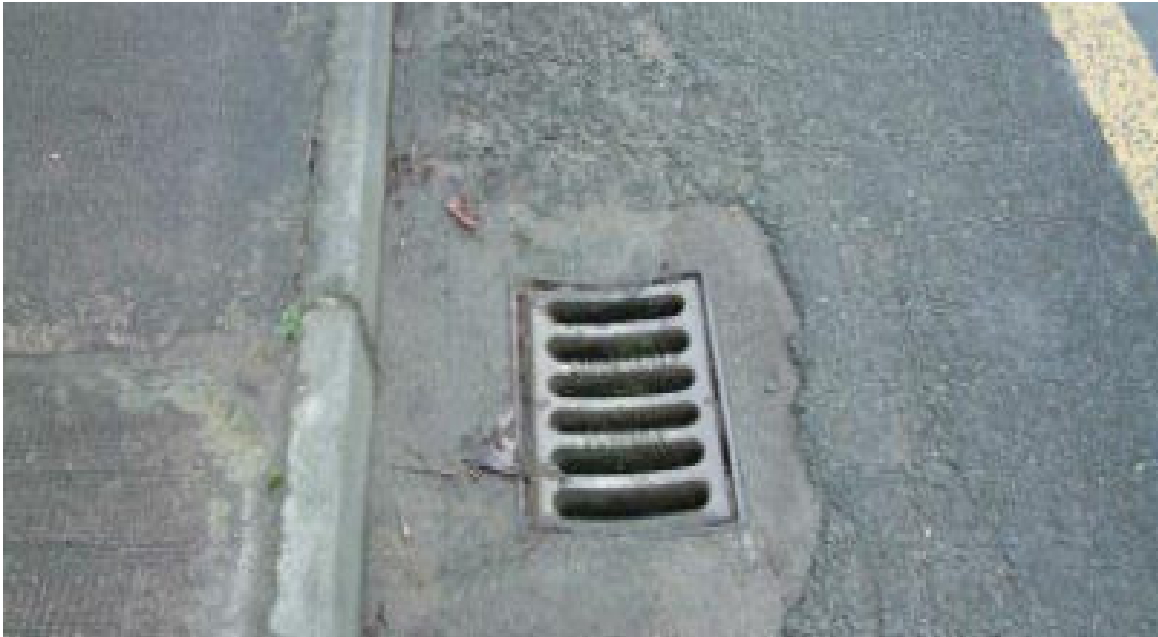
The re-construction of Siluko-Ring Road was carried out in 2011 after years of deplorable state due to flooding as a result of failed drainage system. In just a year after re-construction, the drainage conditions of this road are getting damaged by the passage of time. It is observed that on a segment of the road, the Gully is too far from the kerb (Figure 3). The condition remains same throughout the year causing the drain water to flow on the surface of the road before running off through the gully into the drain. The resultant effect of this on the road is a detachment of bituminous pavement layer due to continuous contact of water. In other words, the pavement is seen to have failed due to stripping of bitumen from aggregates resulting to failure on the edges. There is visibly very poor maintenance culture of the road as majority of the Gratings are barely visible due to blockage by

Figure 3. Gully is too far from kerb.

Poorly executed construction jobs are another factor which contributes to poor drainage and road pavement conditions in Nigeria. Some project contractors and consultants do not adhere strictly to construction job blueprints and the resultant effect of this negligence is poorly executed jobs as was noticed on the Siluko –Ring Road, (Benin. Edo State). From the investigation conducted, it is noticed and as shown in figure 4 that the gully is too far from kerb thus creating room for run-off flowing from the walkway onto the road pavement before entering into the gully. This condition is the same through out the year thus resulting in stripping of the bituminous layer of the road pavement in the areas bounding the gully. The resultant long term effect of this condition if not checked will be a total collapse or failure of the gully facility.

To prevent this condition from occurring, it is highly advised that engineers handling construction jobs should executed them with strict adherence to the blueprints of that exact job.

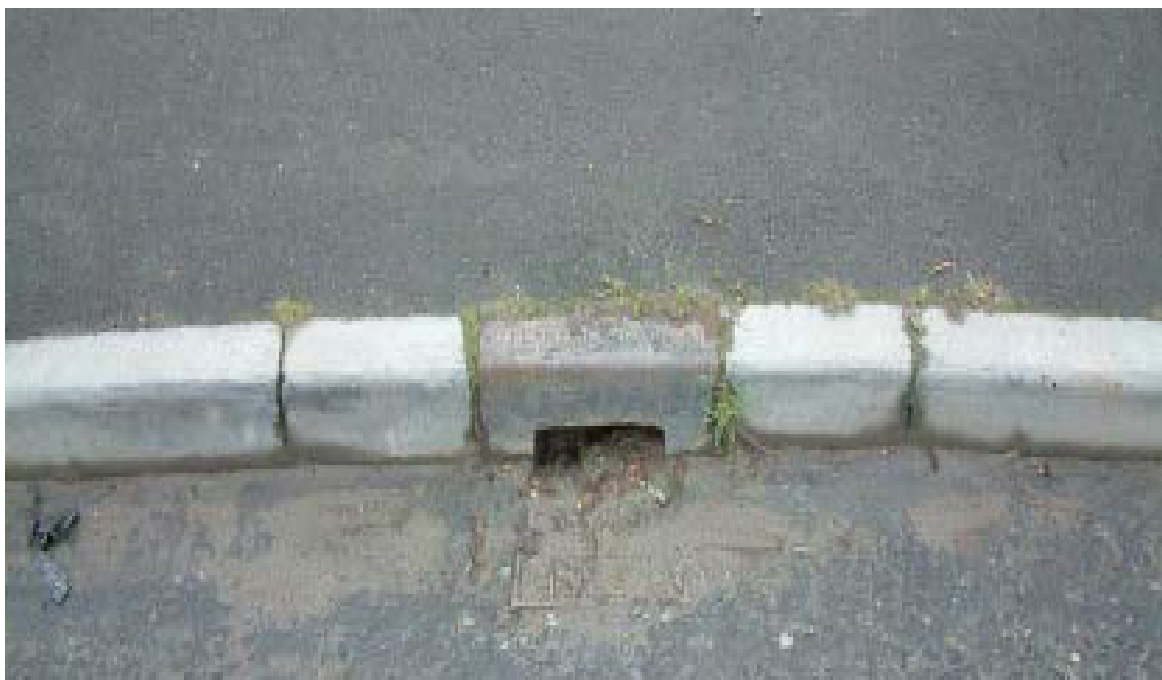
debris and vegetation. (Figure 4)

Figure 4. Poor Maintenance – Grating is barely visible.

To check these very poor conditions of drainages and road pavements, there is need to properly maintain them by empowering the Local government councils under which these drainage channels are located so that they would be able to perform routine cleaning of dirt, weed and Silt sand accumulation over time that is visibly seen to have blocked these drainages (including underground drainage networks) gullies and gratings.

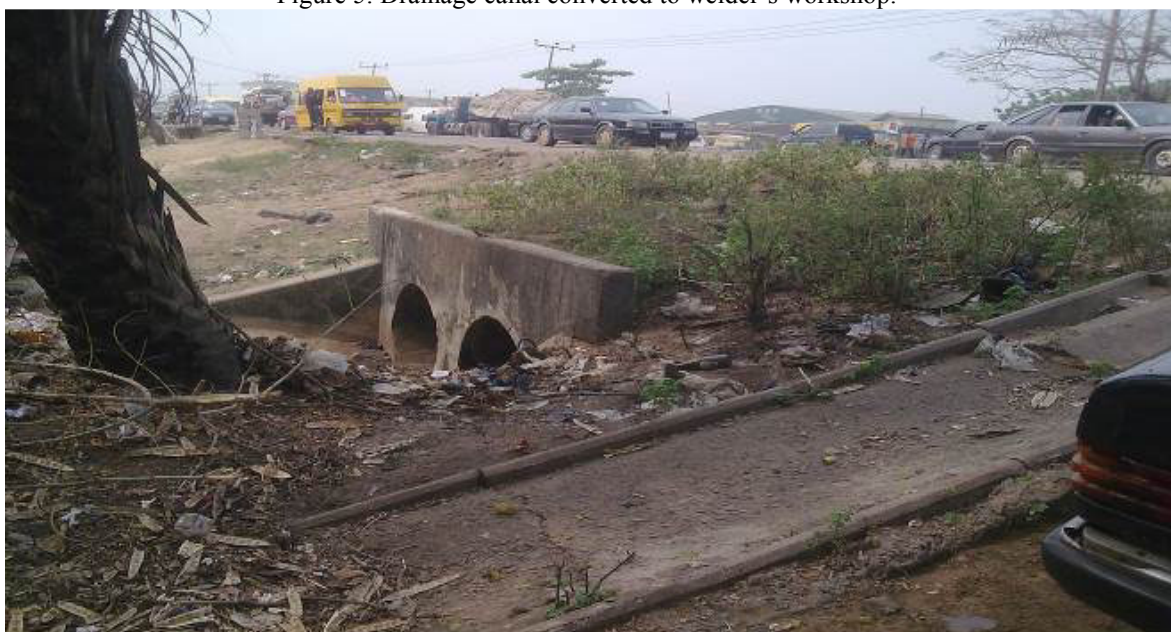
The Lagos-Badagry Expressway is a 60.7 kilometer international Express road linking Nigeria with the neighboring countries of Benin, Ghana and Togo. It was first constructed by the Lagos State government under the administration of Gen. Mobolaji Johnson, the first military administrator of the state from May 1967 to July 1975 during the military regime of General Yakubu Gowon. Since then, the road has suffered massive erosion of infrastructure and abuse of space with people erecting their buildings on the right of way, drainage canals being converted to welder's workshops and culvert outlets blocked with refuse dumps (Figure 5 and Figure 6).

Figure 6. Culvert discharge points blocked with refuse dumps.

The attitude of residents in communities under which these drainage channels are constructed and located goes along way to determining the service lifespan of these drainage structures. From the investigation conducted and as captioned in figures 6 and 7 which clearly shows that residents have converted a culvert into refuse dump site while also converting the land bounding the culverts discharge point into a welder's workshop. This results in blockage of these drains and its subsequent failures which in turn does negatively affect conditions of the road pavement found in these communities.

There is very urgent need for government agencies and concerned bodies to organize sensitization programs

towards enlightening residents on the need to keep drainages located in their communities clean and not use them as refuse dump sites or craftsman's workshops. In situations where these residents refuse to heed environmental sensitizations and warnings, enactment of laws to punish offenders with very strong enforcement machinery should be put in place.

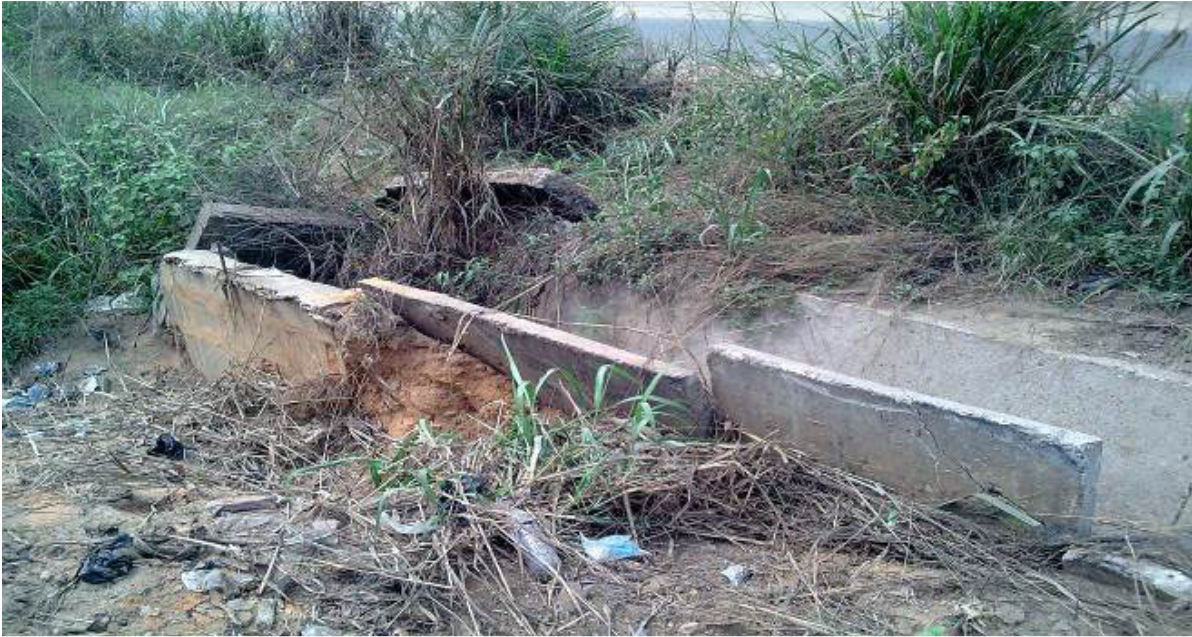
Figure 7. Failed Side drains overtaken with vegetation.

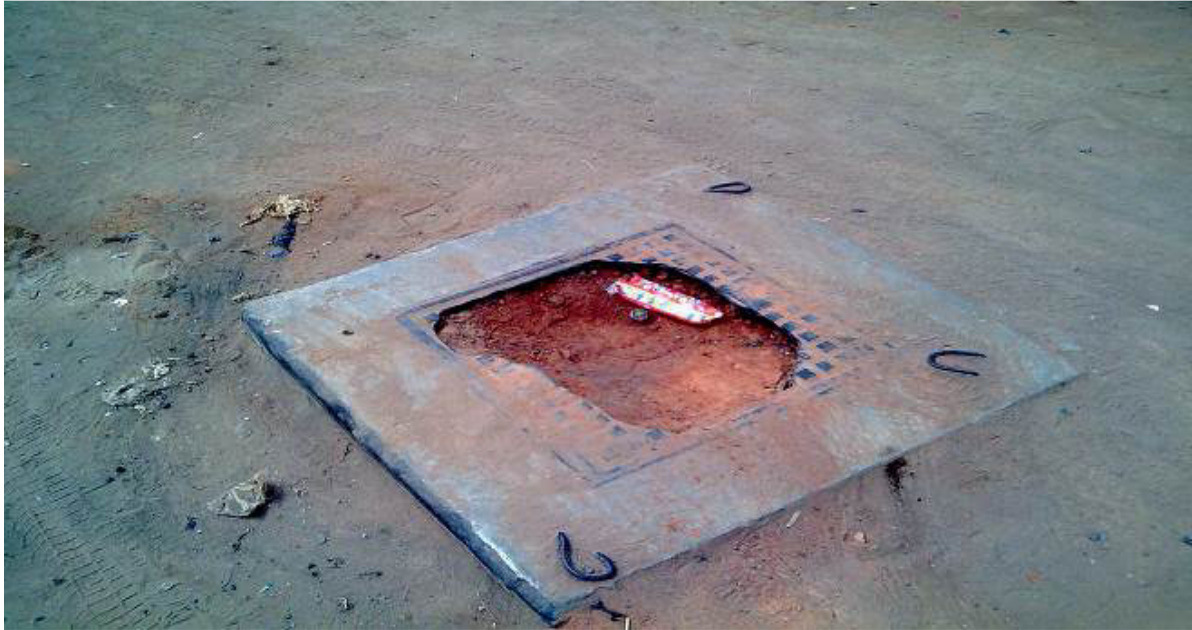
Figure 8. Poor Maintenance – Totally blocked underground drainage network.

When erected structures and facilities such as drainages and road pavements are poorly maintained, their service lifespan is drastically reduced. From the investigations conducted, figures 5,8,9,10,11 and 12 presents proof of this reduction in service lifespan and it is evident in the deterioration of drainages and subsequent road pavement conditions which are visibly noticed in the form of edge failures of road pavements, pot holes along the drive way of road pavements, stripping of bitumen off the surface of road pavements and blockage of drainage channels such as culverts and underground drainage networks. Also these poor maintenance culture results in gullies and gratings being blocked with dirt weed, silt sand accumulation over time and in the growth of vegetation inside and around the side drains which has resulted into total failure of the side drains structures.

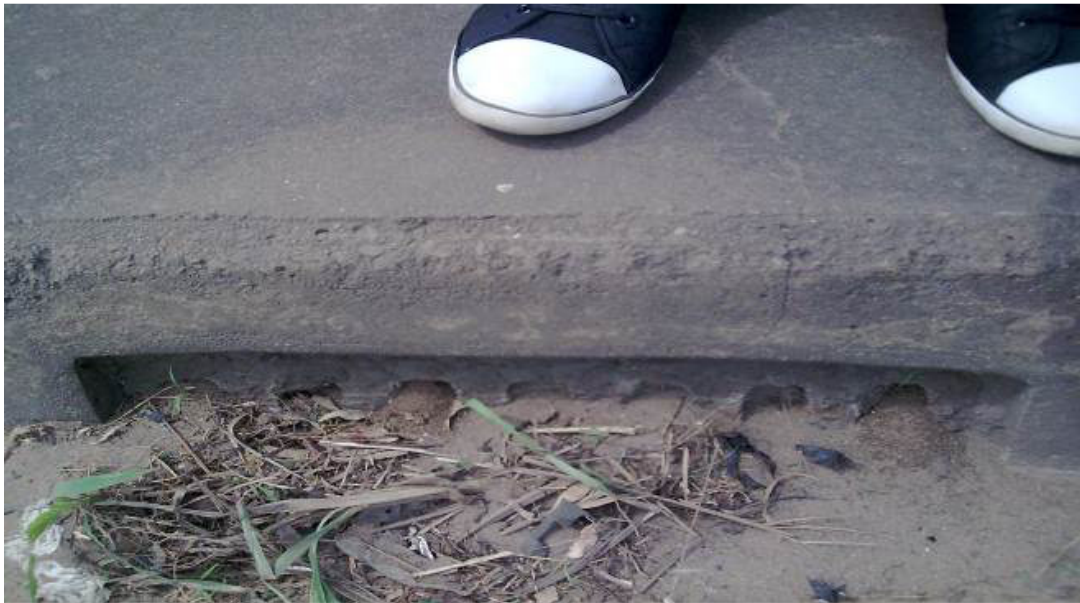
Figure 9. Poor Maintenance – Grating blocked with dirt, weed and Silt sand accumulation over time.

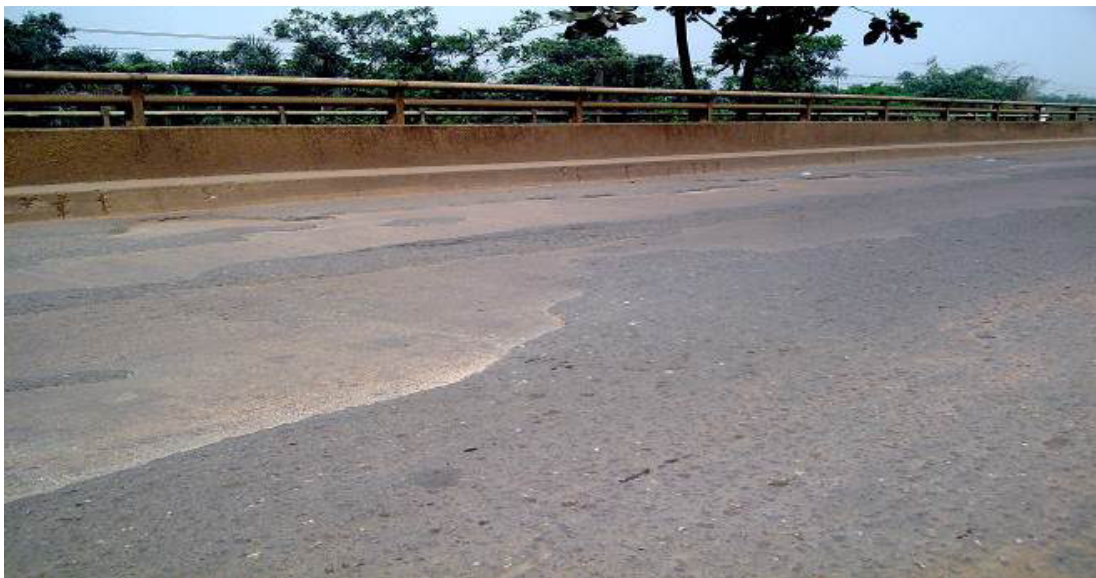
than provide easy passage, it offers a nightmare to land transportation. Foreign nationals from these countries, oftentimes arrive Nigeria through Lagos using the approved land entry points, a showcase of Nigeria to the outside world. Since the Lagos-Badagry Expressway is a major international gateway into Nigeria, its road infrastructure ordinarily should be solidly built and maintained. Ironically, this road is riddled with deep potholes, which cause frequent accidents leading to loss of lives and property. Apart from constituting a death trap, the Lagos-Badagry Expressway which is a federal road is poorly maintained, as physically noticed in the numerous failed side drains overtaken with vegetation (Figure 7) and totally blocked underground drainage network (Figure 8). Entirely all the Gratings on the existing bridges along the length of this road has been blocked by dirt, weed and silt sand accumulation over time (Figure 9) due to lack of maintenance thereby causing water to be retained on the surface of these bridges each time it rains. As a result of this surface retainment of water, the bituminous pavement layer becomes weak thereby resulting in a detachment of bituminous pavement layer (stripping of bitumen) (Figure 10).

Figure 10. Detachment of bituminous pavement layer (stripping of bitumen).

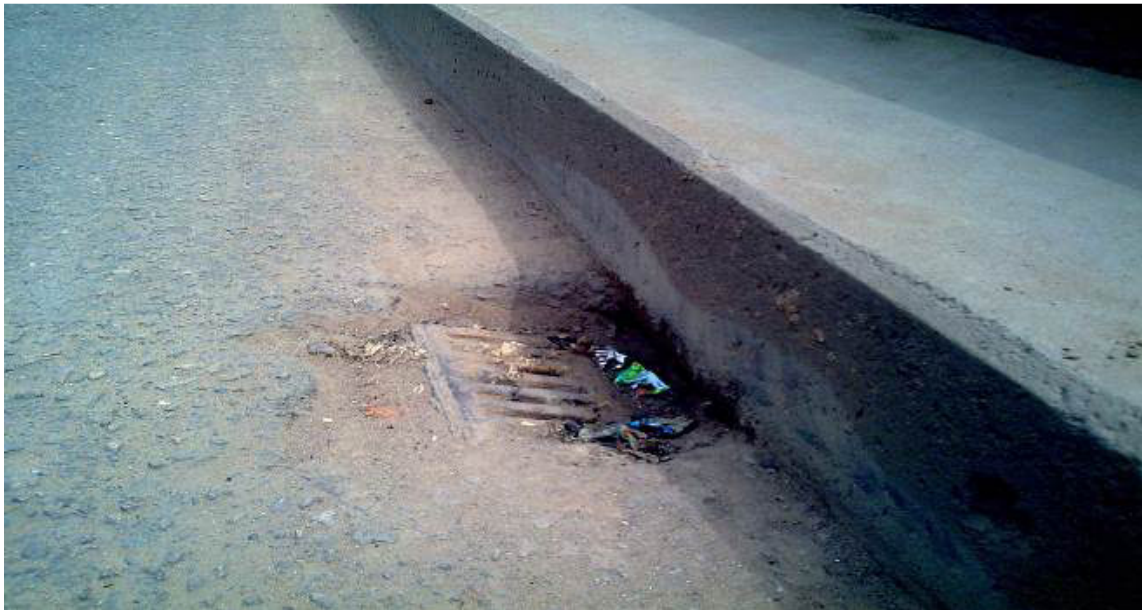
Furthermore, the gullies on these existing bridges are seen to be so poorly maintained and blocked also by dirt and silt sand accumulation over time resulting in drain water to be retained on the pavement surface around the gullies each time it rains thereby causing failure on the edges of the pavement around the gullies (Figure 11)

Figure 11. Poor Maintenance – Failure on edge of the pavement around gully.
