# A Case Study on Blowout and Its Control in Krishna-Godavari (KG) Basin, East Coast of India: Safety and Environmental Perspective

#### **Abstract**

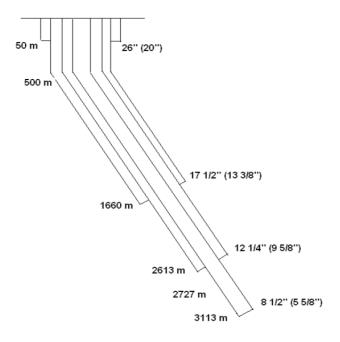
A raging blowout (Bhaskar, 2005) occurred in an exploratory well in the East Godavari District of Andhra Pradesh in Jan'95. The well was spudded in Sep'94. The bit sizes and the casing details of the well were given in (**Table 1**) and the well configuration is shown in (**Figure 2**). The drilling progressed with 8.5 inch bit and with a drilling mud specific gravity of  $1.3 \pm 0.1$ . The bit had stuck at the depth of  $\approx 2727$  m MD which was confirmed by conducting a stretch test. The stuck up might be due to many reasons which were discussed in the coming sections. An attempt has been made to retrieve the drill rods by unscrewing, which was successful. Unfortunately, they were unable to retrieve the drill bit and drill collars and were left in the well bore. It was reported no kick off pressure recorded until this stage.

Figure 2. Schematic of well configuration (Jain 1995).

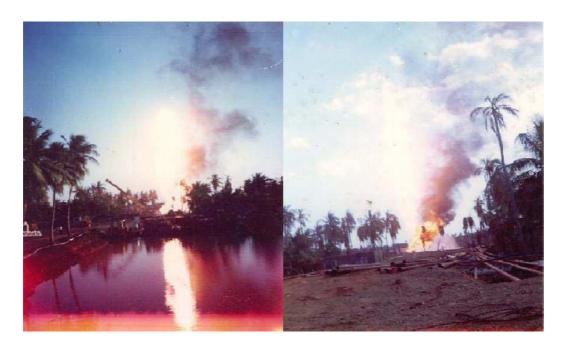
As alleged, in the evening, uncontrolled flow of gas to surface at high pressures led to a blowout. The spewing gas caught fire immediately. The remaining pipes inside the bore were thrown out by the enormous pressure of the gas. The derrick and the surrounding equipment were gutted after the blowout. The pressure (Jain, 1995) of the gas was estimated around  $281.2 \pm 0.5 \text{ kg/cm}^2$ . The sound resembled like a rocket engine and the level was so high that none can hear anything up to 700 m distance from the site, necessitated the use of ear plugs. In the night, the intensity of the light caused by the flame was so high that it is visible up to a distance of more than 2 km from the well site. The gas flames (Pantulu, Satyanarayana, 2005) were about 200 feet high with temperature shooting to more than 50°C. About 1 million m³/day of gas spewed out with a deafening sound as shown in (**Figure 3**).

Figure 3. Real photograph showing the height of the flame and the spewing gas.

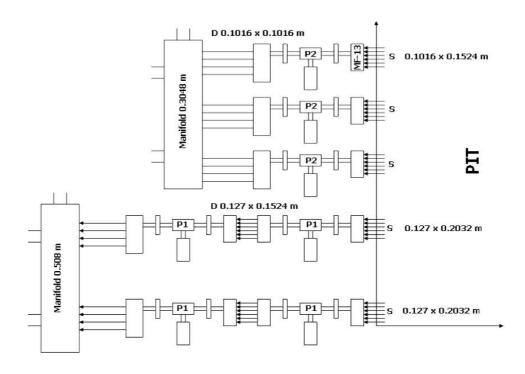
- Six pumps of 20,000 gal/min total capacity were used for spraying of water and to create a water umbrella over the flame to reduce the temperature of the flame and surroundings for approach of the safety rescue personnel and for clearing the debris at the site. To prevent the damage of the pumps, they were placed in the well site. A schematic of the pumps arrangement used for combating the blowout is shown in (Figure 4). The details of the pumps used for pumping the water are given in (Table 2).

Figure 4. Arrangement of water pumps to create a water umbrella over the flame (Jain, 1995).

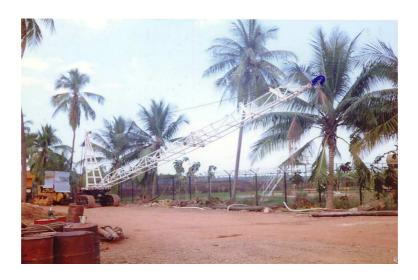
- Athey wagon (**Figure 5**) was employed (Kelly, 1993) to clear the debris at the well site so that it was easier for the safety rescue personnel to reach within 20 m radius of the blowout area.

Figure 5. Athey Wagon clearing the debris at the well site.

- Drums of plastic explosives of each approx... 200 kg were dispersed over the flame, to suck up all the oxygen and to extinguish the fire. But many attempts failed. In another attempt, approx... 400 kg of plastic explosive was dispersed onto the flame with the help of Athey wagon and the finally the fire was extinguished. This brought much needed relief to the crew and experts at the well site.

- The surroundings were cleaned with the use of Athey wagon, bulldozer and a crane with hook. A relief well (Wright, 1993) from a distance of 1.5 km from the site of blowout was drilled to connect to the bottom of the blowout well. High density drilling mud was pumped to control the flow of gas from the reservoir into the well bore. The choice of spraying foamy fire retardant chemicals was not tried to put off the fire.
