Environmental Impacts of 2005 Earthquake: A Pre- & Post Disaster Situation Analysis of District Muzaffarabad

Sumeera Siddique Alia Naz, Muhammad Ziad Abdullah Khan Muhammad Rizwan
Department of Environmental Sciences, University of Haripur

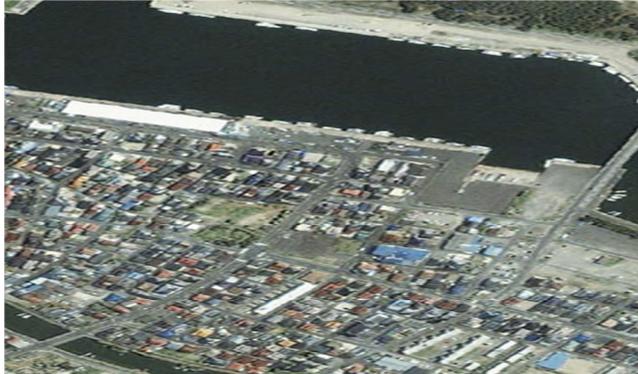
Figure 1: Satellite image Pre 2005 earthquake

These parameters were shown through satellite images and described below (Figure.1, 2 &3):

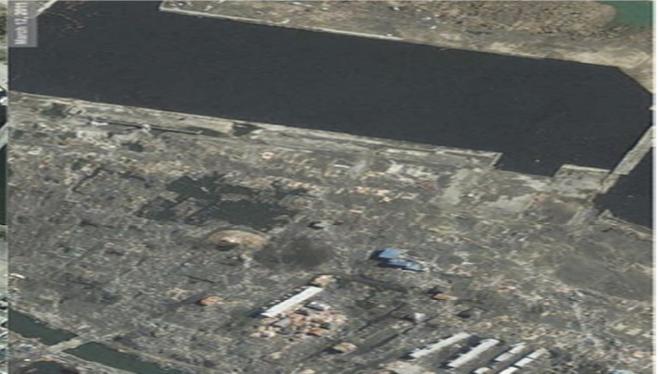
Figure 2: Satellite image Post 2005 earthquake

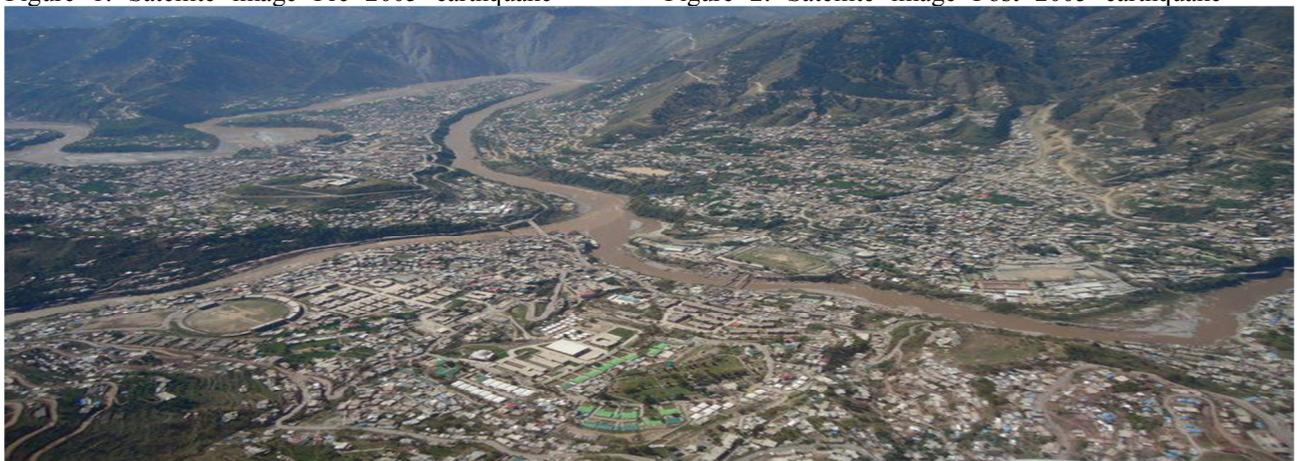
Figure 3: Image Post Earthquake in 2015

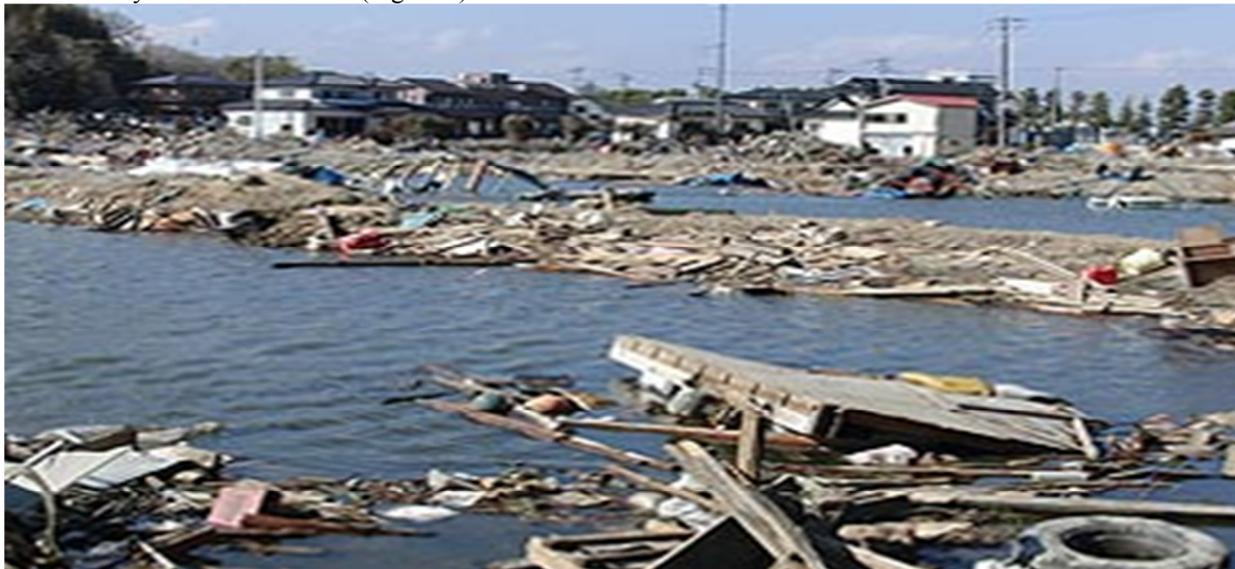
Figure 5; Debris affects the quality of water

By applying T test, compared the pre, post and current sampling of water and to analyze the changed in the pH of water. In T test it showed 2tailed significant .000 and acidic in nature, the reason of this acidic nature was observed that all the sewerage, industrial and mining waste which had pH range of 2.0 and more acidic in nature were directly thrown in the river (Figure.5).

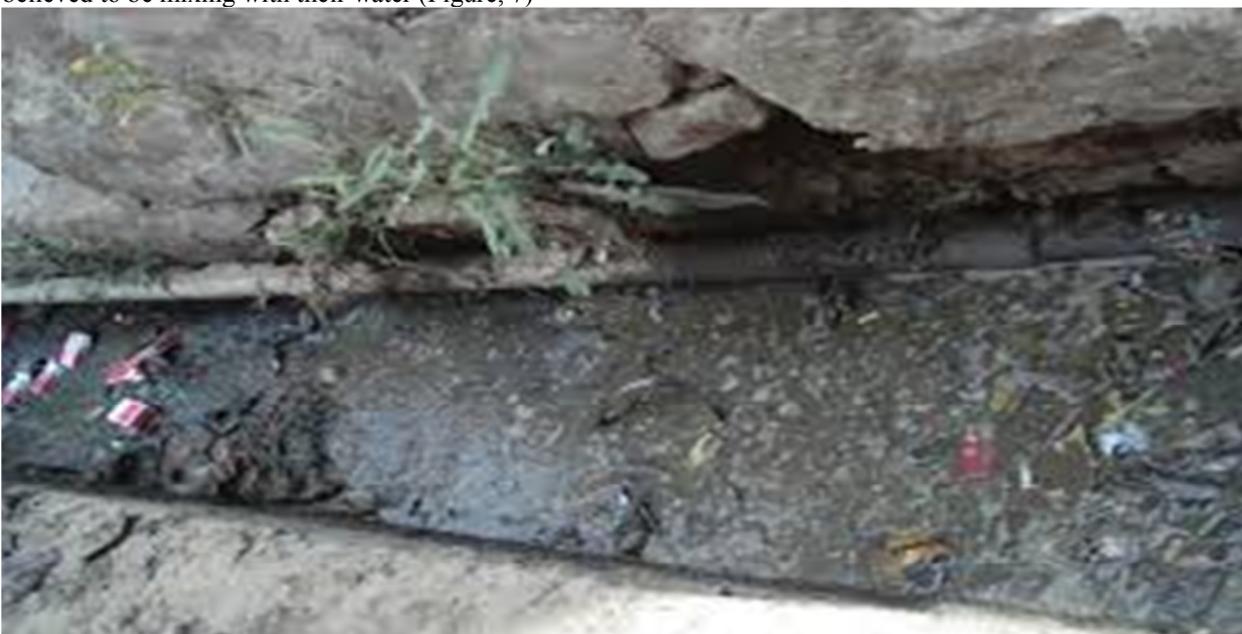
Figure 7: Drinking water pipe passes through gutter channel

After applying the T test it showed that there was a significant change in the water quality after passing ten years of 2005 earthquake still had impact on the water quality. The reason of this increase in no of E.coli was that in the capital city almost all the natural springs were in the lower side of the city and gutter water was believed to be mixing with their water (Figure, 7)

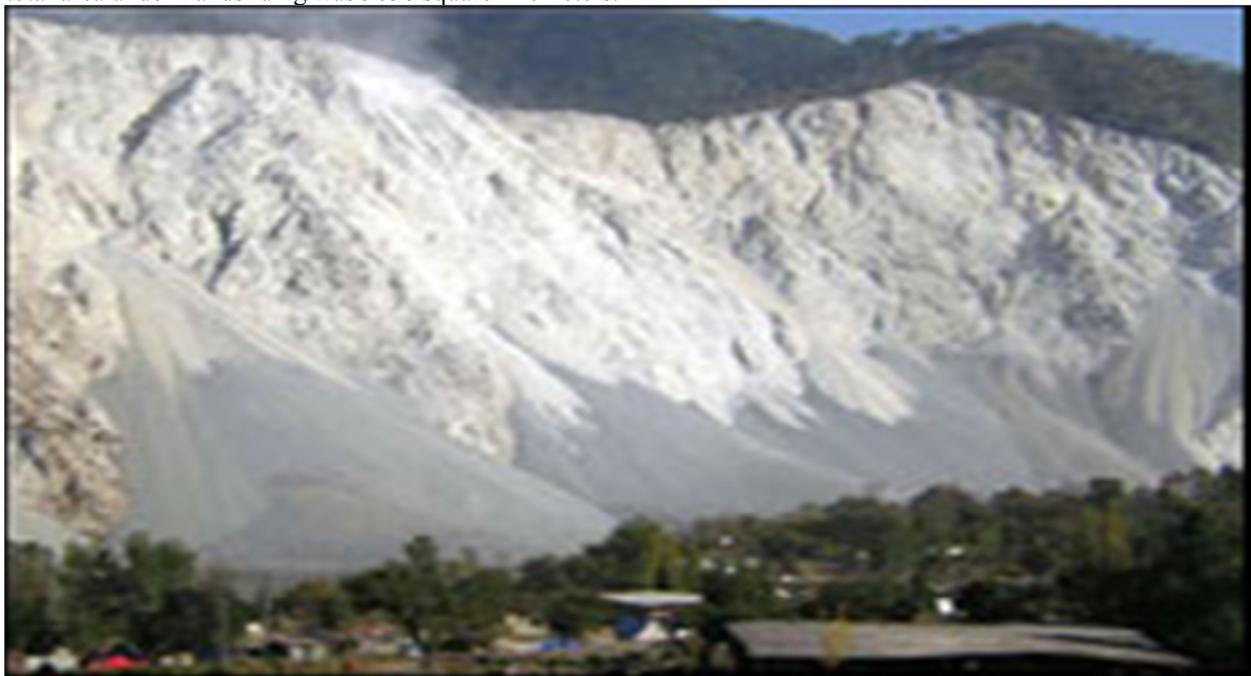
Figure 8: Landslides in Muzaffarabad

During the period of 1998 to 2005 there were only 337 land sliding incidents recorded, (Figure,8) where the total area under Landsliding was 9638 square kilometers.

Frequency of land sliding was 0.167 per square kilometers and average land slide size was 0.0286 square kilometers. So as a total percentage area of Landsliding in Muzaffarabad was 0.48 % and this was shown in below table 4.

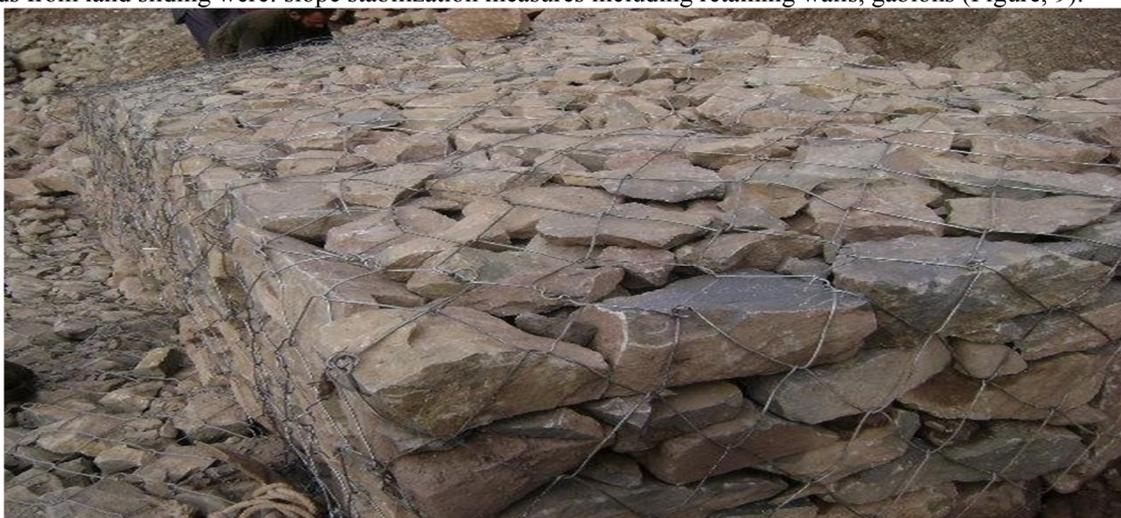
Figure 9: Gabions Walls

Now government takes some positive steps to overcome the Landsliding situation and its further damages. Due to this no of slides decreased as shown in the table 4.6. The reasons of this decrease in no of slides were that during the reconstruction, the government of Muzaffarabad had used many important measures to protect the roads from damages caused by land sliding. Some of the basic measures that had been taken for protection of roads from land sliding were: slope stabilization measures including retaining walls, gabions (Figure, 9).

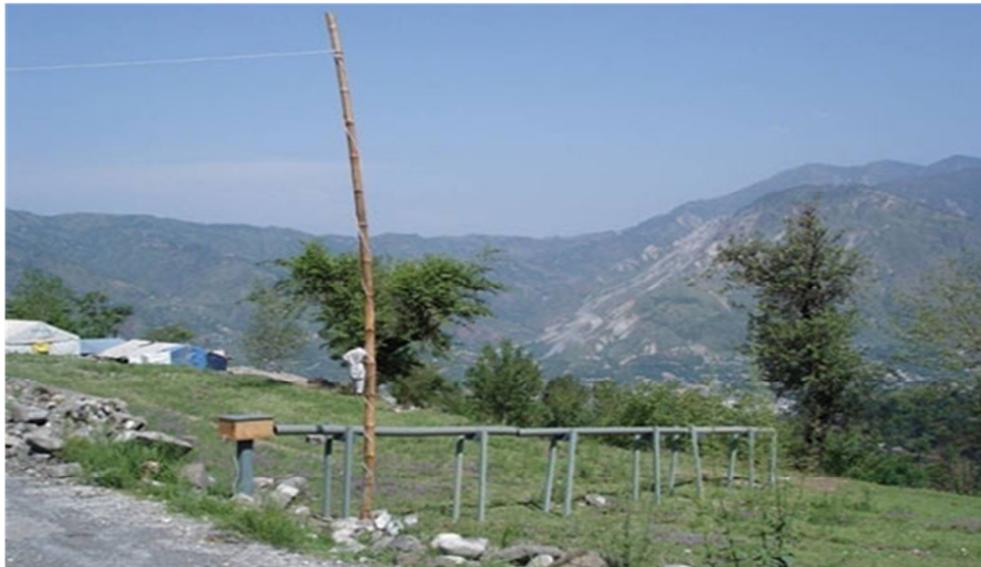
Figure, 10: Using extensometer apparatus

While on the other hand, few technical prevention measures had also been established. In this measure system, on two main critical sites in Muzaffarabad, early warning system for landslides had been installed. Which is, ten wooden battens, and two digital extensometers along with two rain gauges were installed to monitor the slope movements. The extensometer installed in Ranjata area was then connected to a siren to warn the community (Figurer, 10). The system was set up in a way that when the instrument observed a ground movement more than the specified one, it sent signals to the alarm unit, which would then activate the revolving light and the siren to warn the community of the danger of landslide. Necessary settings were made in order to prevent false alarms due to contact by animals or human error. The instruments were installed in the wooden boxes to protect them from water and direct sunlight, as well as from security point of view. All the wood used in the installation had properly been painted in order to protect it from severe weather conditions.
