# Enhancement of Small-Scale Runoff Harvesting Ponds in East Africa

## Abstract

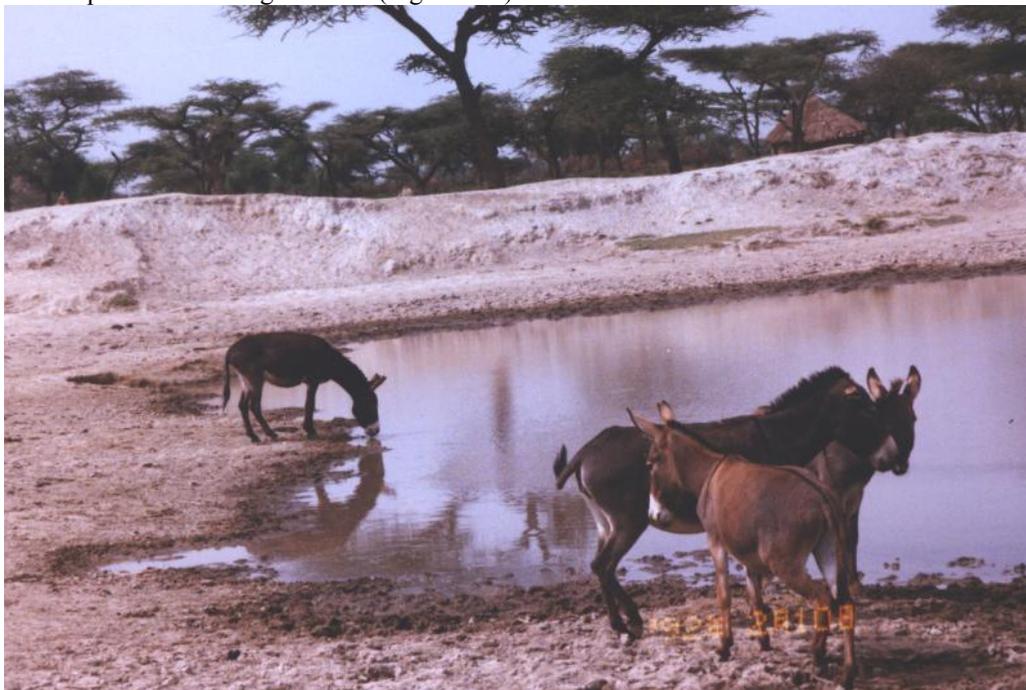
Figure 2.1 Uses of water for domestic animals

**Uses of harvested water in the area.** The water that has been harvested around this project area is being utilized for different purposes such as watering domestic animals, washing purposes, and even for human consumption in time of great need (Figure. 2.1).

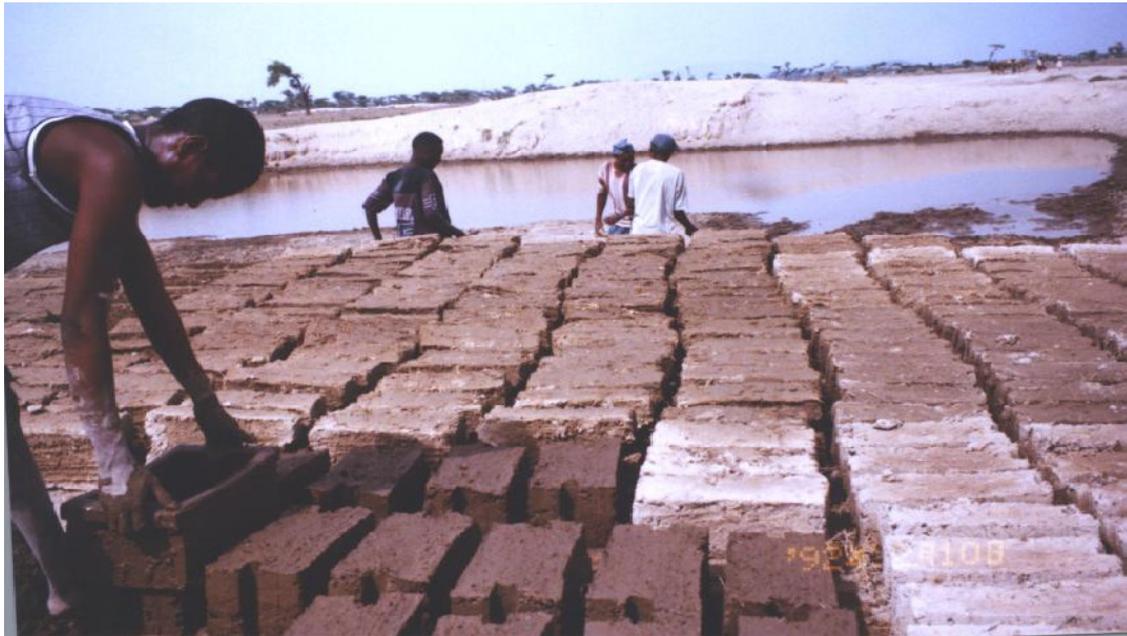
Figure 2.2 Uses of water for mud-block preparation

In this project area, the harvested water was also being utilized in the fabrication of hollow mud-blocks, a source of income for the owners of the pond (Figure. 2.2). However, this income-generating project has never fully developed due to the excessive seepage losses and short holding times for stored water in the ponds.

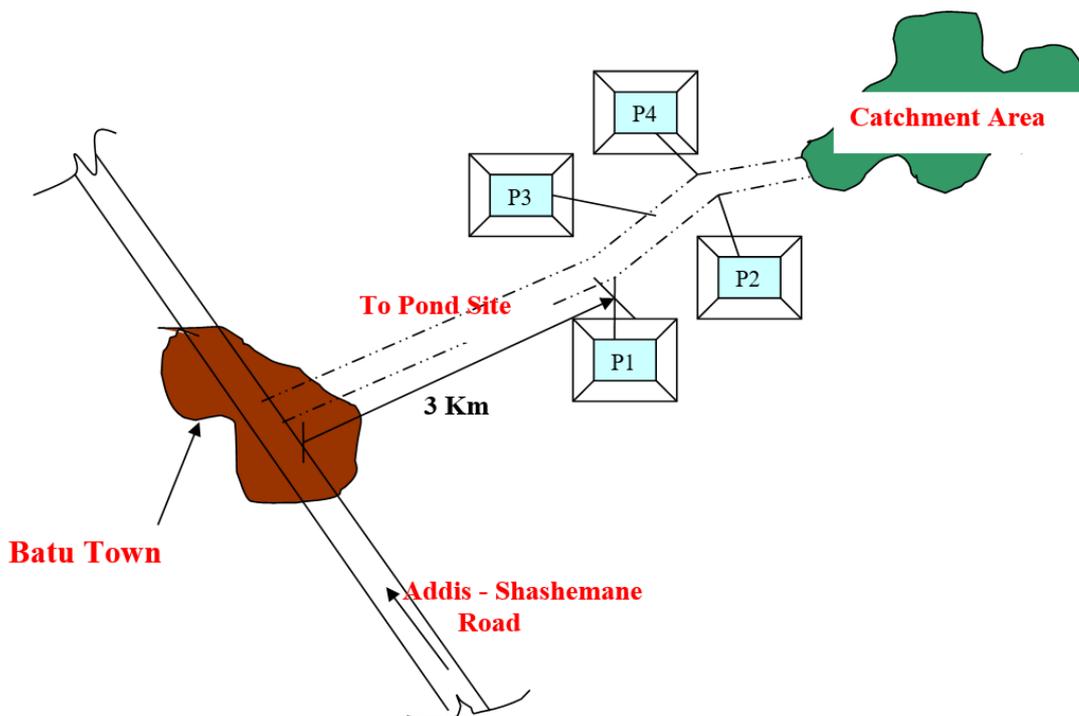
Figure 3.2: Schematic layout of the project area ("P" = pond).

The research project is in Oromia Region, Arsi Zone, Adami Tulu Jigdo Kombolcha District, and Kemo Gerbi Peasant Association (PA's) (Figure 3.1). It is located at 3 km east of Batu town which is the center of East Shewa Zone. Its specific location lies at Geographic coordinate of 7°55'50" N Latitude and 38°41'20" E longitude. The average altitude of the project area is 1660 meters above mean sea level (m.a.m.s.l). For schematic layout of the project area, refer to Figure 3.2. The four ponds are labeled as P1 through P4, and the catchment area is the total sub-watershed which is channeled into the ponds via the constructed drainage way.

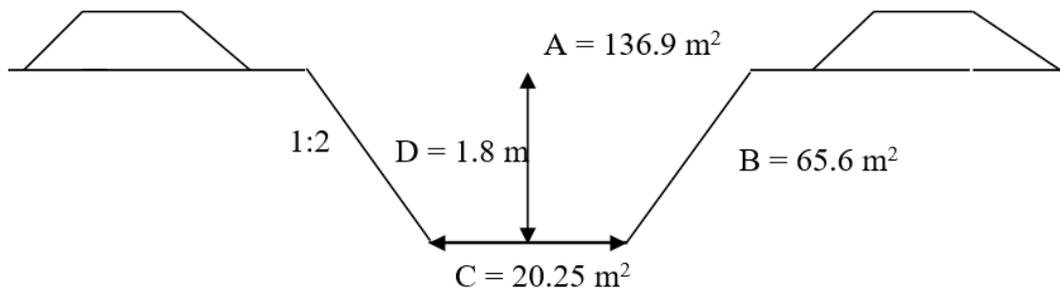
Figure 3.3: Cross section of the pond. Each pond was constructed with the same dimensions.

The volume of the pond required was fixed based on the amount of water needed to supplement crop failure during peak periods of water requirement by crops. The design parameters of the ponds are as shown in Figure 3.3 below. The pond so designed was therefore made to have a total volume of 126-m<sup>3</sup> at depth of full pond. A 20 cm earth fill around the pond was provided to serve as a free-board.

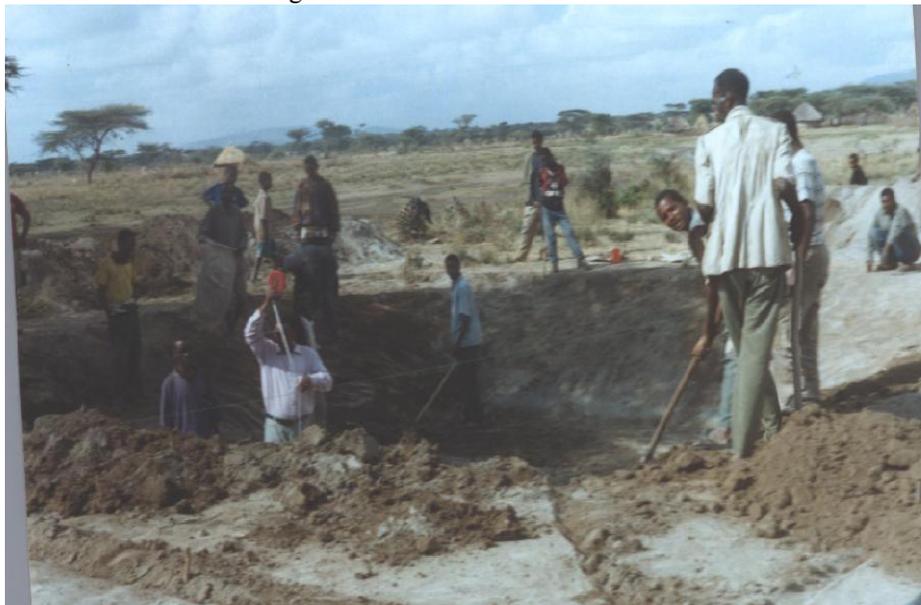
Figure 3.4: Pond excavation control

The construction of the pond was made after clearing and removing of the weeds in the proposed pond site using local labor. After carefully laying out the pond dimensions on the ground using a rope, pegs and line level, excavation was made on the bottom area and sides walls of the pond. Treatment of the sides slope (trimming or cutting) was made using a spade with the help of a rope as a guide. The pond construction process by the methods discussed above is shown in Figure 3.4.

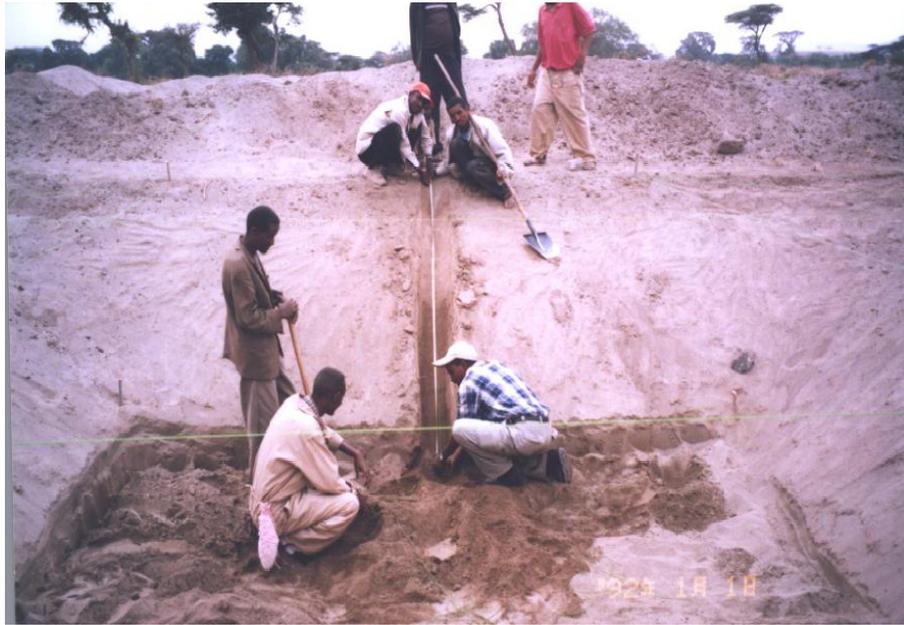
Figure 3.5 Trimming of the pond sides

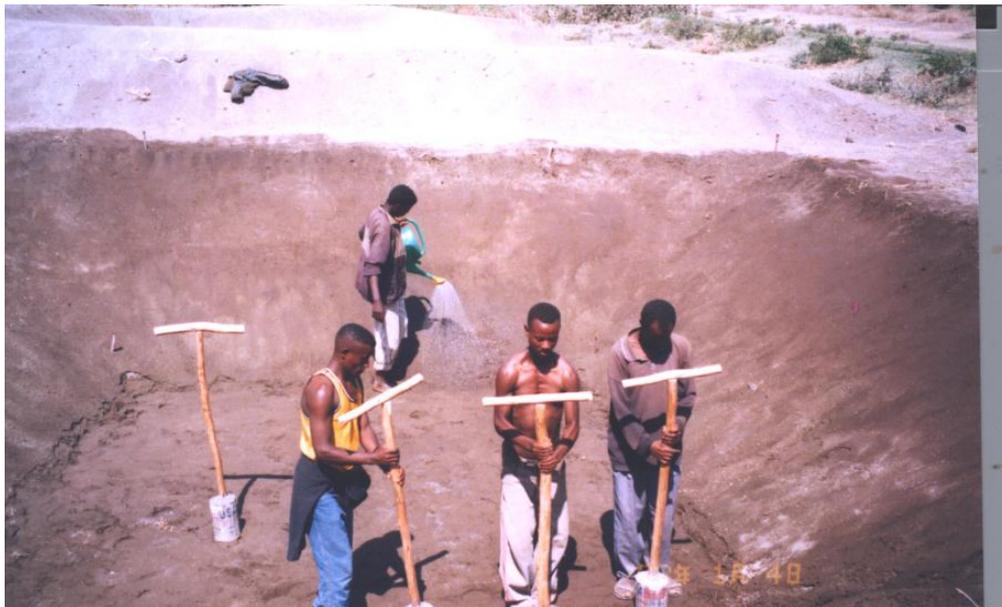
Figure 3.6 Compaction of the pond

One of the methods for the attainment of water tightness in ponds is compaction. Since the soil material of the site is well graded from small gravel or coarse sand to fine sand and silt, the pond can be made relatively impervious by compaction alone. Prior to compaction, the soil was cleared of all vegetation and holes and crevices were filled with uniform material. Here all debris and pieces of tree roots were removed. The loosened soil was compacted to dense, tight layer using a manual compaction tool made from a wood / cement paste poured into a can. The pond compaction was made after watering the bed and side slopes of the pond and tamping it using the compaction tool prepared on the site. The thickness of the compacted liner was approximately 10 cm after compaction. An extra 10 cm was excavated at both the sides and bottom of the pond to be eventually filled by compaction. The watering of the pond and the compaction process is shown in Figure 3.6.

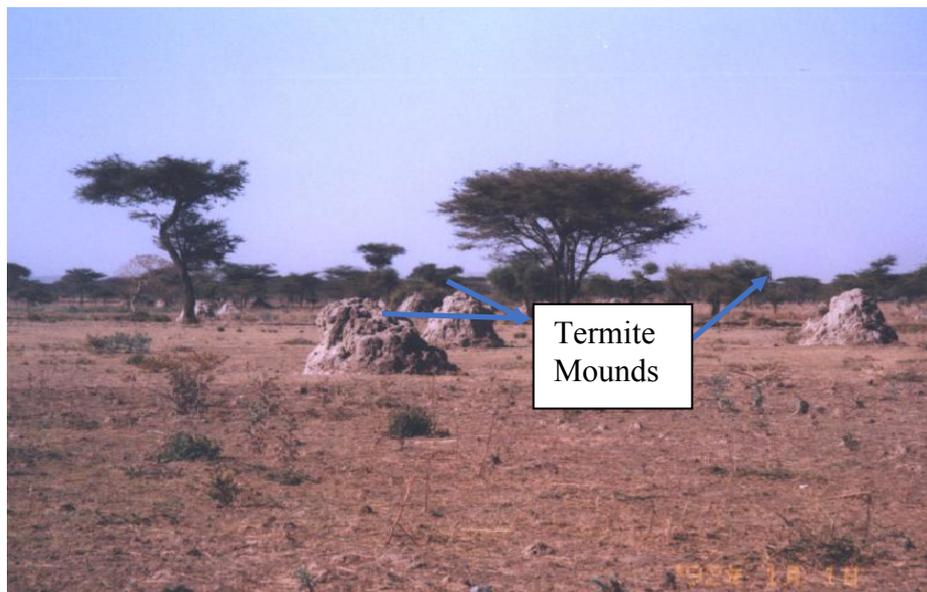
Figure 3.7 Termite Mounds for treatment

Traditionally, termite-mound has been used as one of a sealing mechanism of ponds. The termite mound is prepared by soil microorganisms (termites) by bringing soil from a deeper layer and mixing it with their secretion to bind the soil particles together. Local farmers acknowledge that the soils prepared by so doing was found out to be watertight. Hence, termite mound (kuyisa) was selected as one of the treatments materials (Figure 3.7).

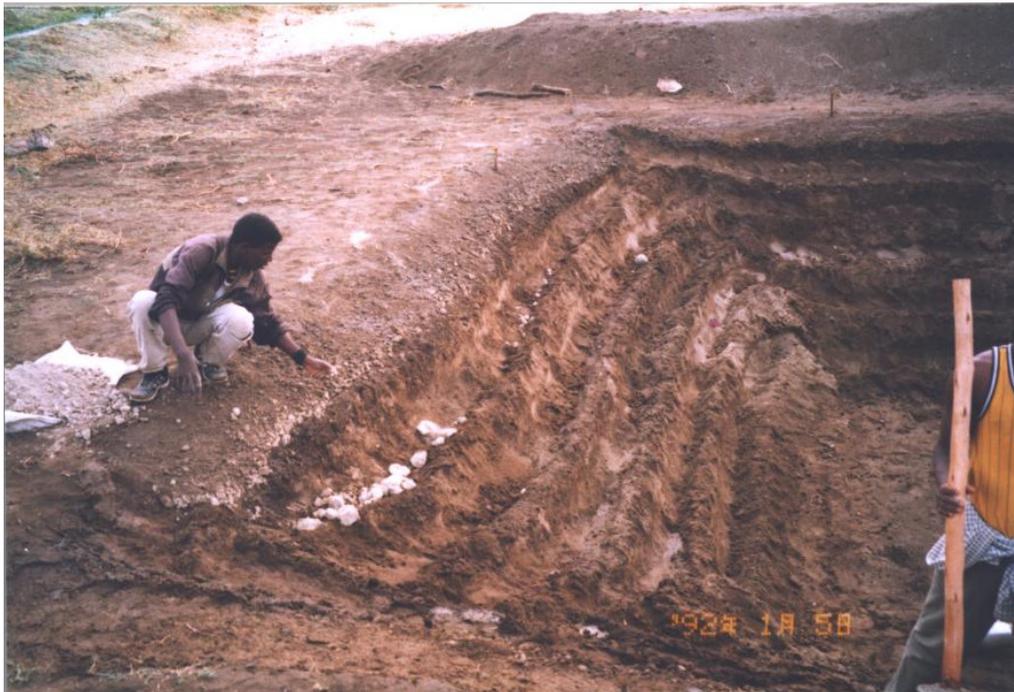
Figure 3.8 Treatment by Termite-mound

Treatment of the pond with a termite mound needs a very careful construction process as it is going to be constructed on the side slope of the pond (there should not be caving of the treated bank material). Hence, before the treatment begun, the side and the bottom of the pond were compacted. Then a contour was made on the sides of the pond to prepare it for putting the termite mound on the side to prevent the amendment material from falling into the bed of the pond. The treatment technique is shown in Figure 3.8, 3.8.1 and 3.8.2. The thickness of the mound material used was approximately 10 cm upon compaction.

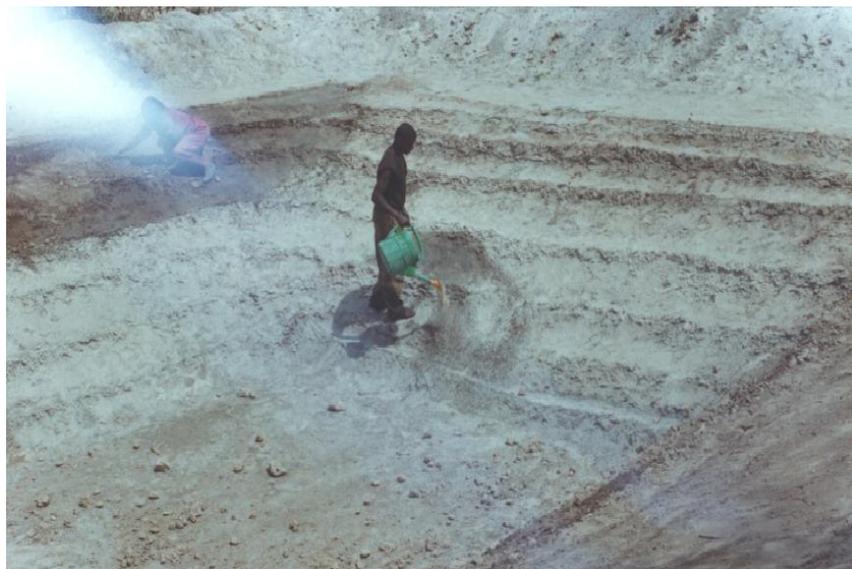
Figure 3.8.1 Preparing terraces on the pond sides

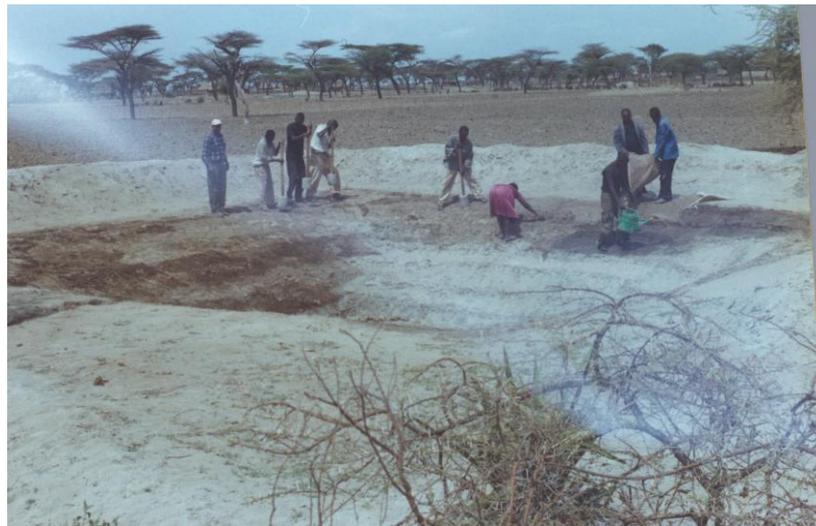
Figure 3.8.2 Treatment by termite mound and compaction

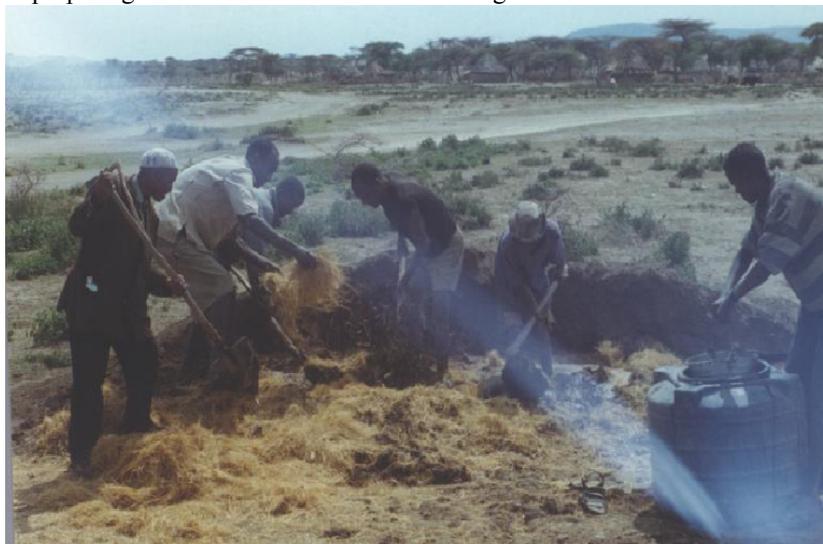
Figure 3.9 preparation of the soil-straw mix

The soil: straw mixture was a final treatment method used in this study. The soil used in this treatment is obtained by excavating a clay loam soil about 4 km distance from the pond site. About 15 m<sup>3</sup> of soil was transported using a double cabin pick-up truck for this purpose. The straw added to the soil was obtained from a local market. The local crop, teff straw, was selected for this purpose as it can be easily mixed with mud and is very common in the region. The infiltration rates of the selected soil were tested in the field by digging 10 cm diameter and 30 cm depth hole, filling it with water and evaluating its impermeability through measuring the draw-down over 3 hours. The soil-straw mixture was prepared by local labor in a similar fashion as that of the plastering of houses to build a mud wall. The soil-straw mixture prepared was cured for 3 days to have a good mix. The process of preparing the soil-straw mix is shown in Figure 3.9.

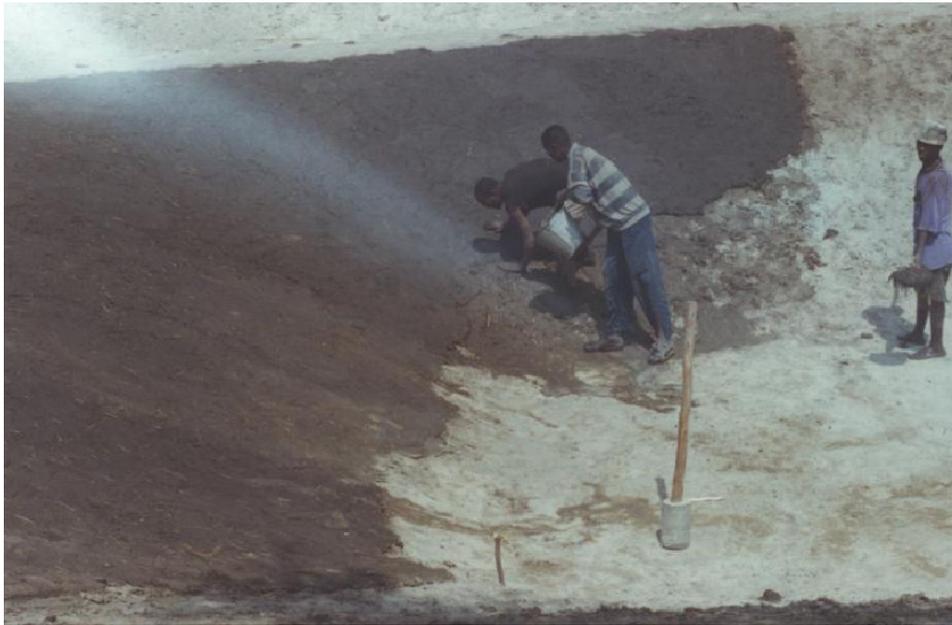
Figure 3.10 Treatment by soil-straw mixture

- Watering the excavated and finished surface of the pond both on its sides and bottom.
- Making a hole into the side slope using a wooden stick to create good bond between the pond and the treatment material by getting the material forced into the hole.
- Applying the soil: straw mixture or plastering the pond surfaces in the same way as the traditional mud plastering (Figure 3.10)

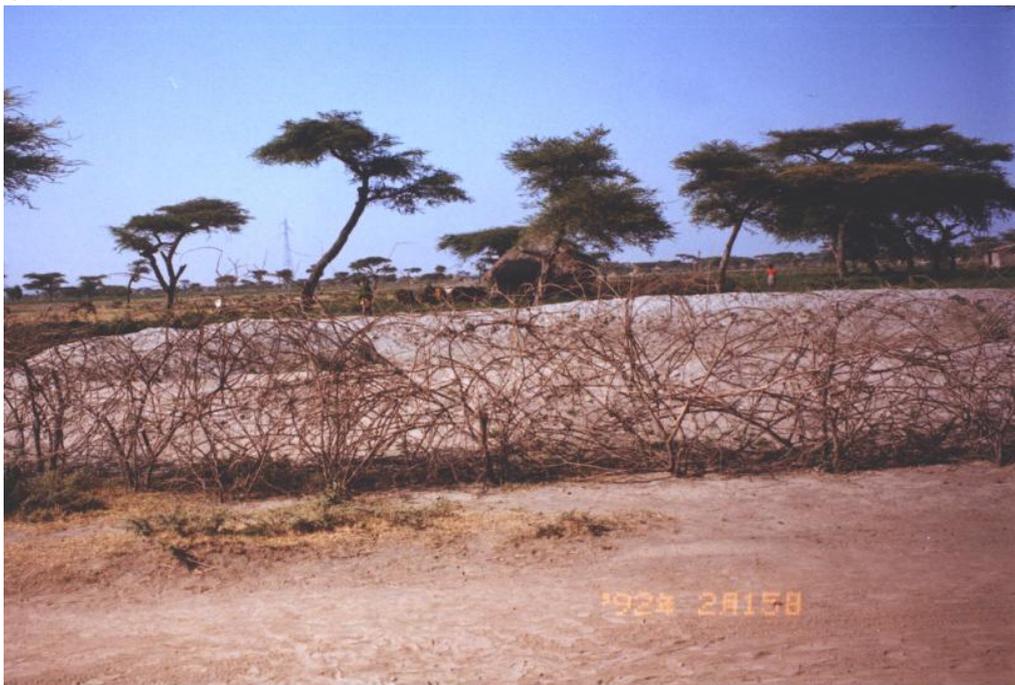
Figure 3.11 Fencing of the pond (typical of all four ponds).

After the necessary construction work is completed, the pond is fenced with a locally available material to prevent the pond from being accessed by children and domestic animals. The fencing done in this case is shown in Figure 3.11.

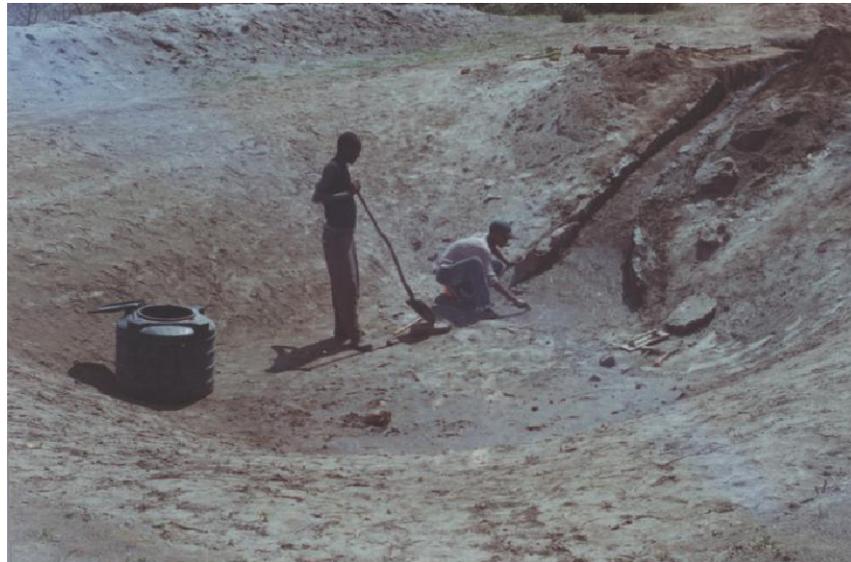
Figure: 3.12 Pond inlet and the staircase

erosion during the pond filling was overcome by using a staircase-type water channel, which was constructed to serve this purpose. The staircases have another benefit of serving as a means (a walk way) to abstract water from the pond (Figure 3.12).

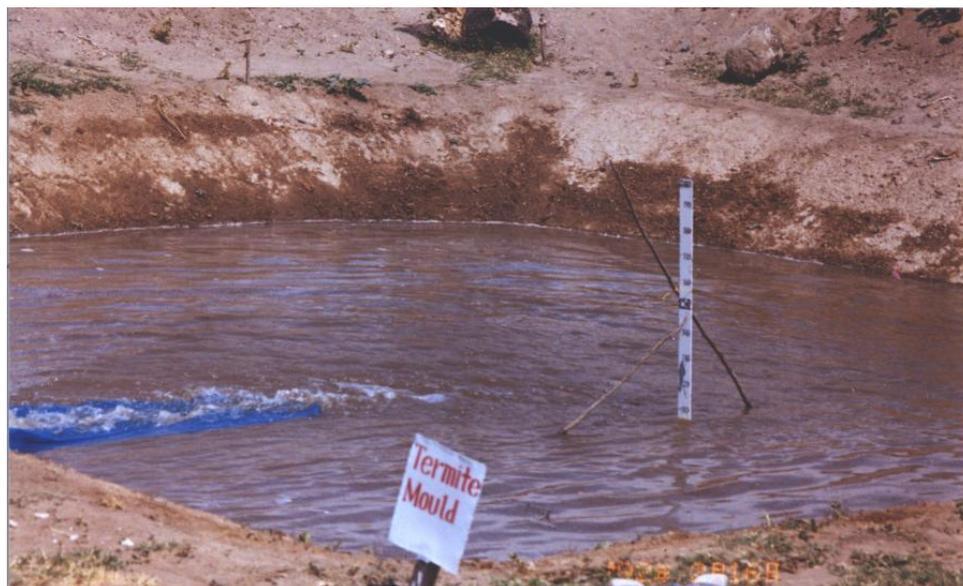
Figure 3.13 Pond filling & staff Gauge

The filling of the ponds and level measurement is shown in Figure 3.13. All the ponds were filled to the same initial depth of 175 cm, so that the initial static head level would be the same.

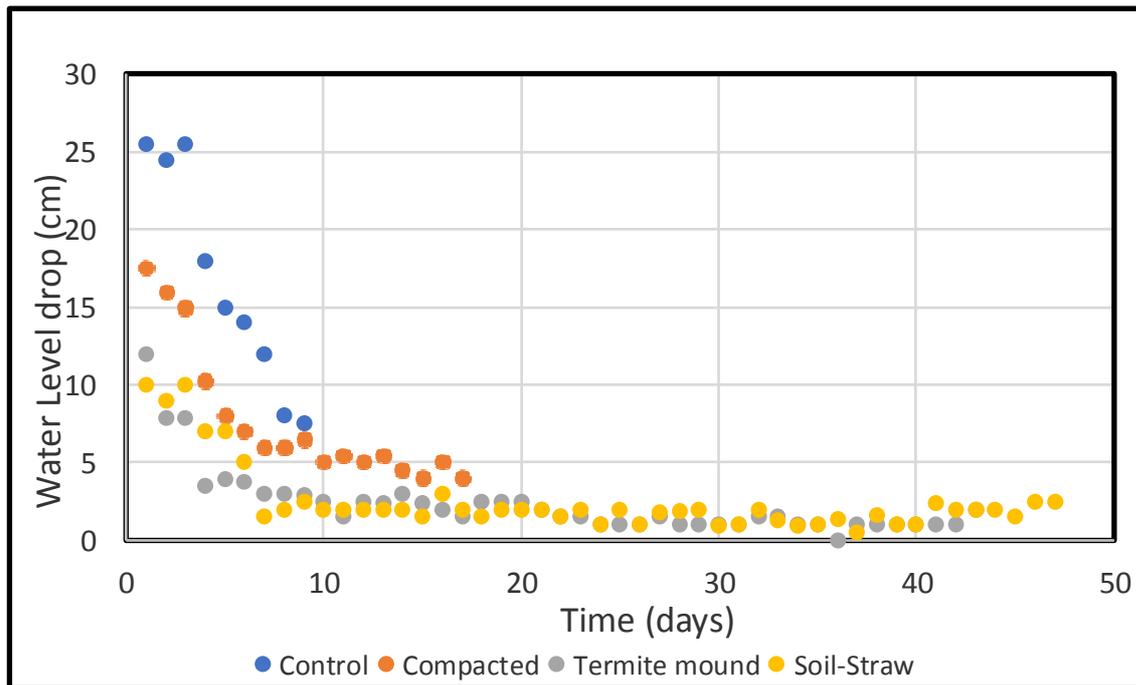
Figure 4.1: Daily water level drop vs time

The data collected is graphed to compare the amount of the level drops from all the four ponds. Figures 4.1 and 4.2 are used as a summary to analyses the results obtained. The analysis made for all the ponds are summarized as follows:

Water level drop from the pond used as a control reached an amount of 149.5 cm from the total filling height of 175 cm only in the first day of the filling which is 15 % of the total storage level. This means there is a level drop of 25.5 cm in only the first day of the filling. This level drop continued for the next three days. The level drop becomes 15 cm/day on average starting from the fourth to the seventh day and then reaches an average level drop of 8 cm/day for the remaining periods. Eventually, complete drying of the pond could be observed right after the ninth day.

The drop of water level from this pond reached 17.5 cm from the total filling height of 175 cm only in the first day of filling. This amounts to about 10% of the original water level. The decrease in the water level continued for next 5 days with an average daily drop being 11.5 cm. The level drop remains constant over the subsequent 11 days with an average being 5.5 cm/day. The pond contained half of the filling level for about 7 days (1 week). The overall duration that the pond contained water is about 17 days.

The drop of water level in the pond in the first day of filling is 12 cm. It means that the stated amount of water height is lost through percolation, filling of pores of the treatment material and partially through evaporation loss. The drop of level from this pond continued to reduce for the next two days with a daily amount of 7.9 cm. It continued to drop by an average amount of 3.4 cm/day starting from the fourth to the ninth day after the first filling, and then after reaches a constant amount of level drop of about 2 cm/day on average for the remaining periods. The pond contained half of the total filling height for about 15 days. The ponds reached 50% of the level drop of the original fill height of 175 cm. It could contain water for 43 days.

In this pond, the drop of water level on the first day of filling reached an amount of 165 cm from the initial filling height of 175 cm, which is 10 cm level drop and this level drop continued with the same amount every day up to the third day. The average level drop starting from the fourth day to the sixth day was found out to be 6.5 cm/day. Then after, it continued to drop with an average amount of 1.75 cm/day starting from the 7<sup>th</sup> to 47<sup>th</sup> day after filling. Furthermore; it could be observed that this pond contained water for 47 days, which is about 7 weeks.

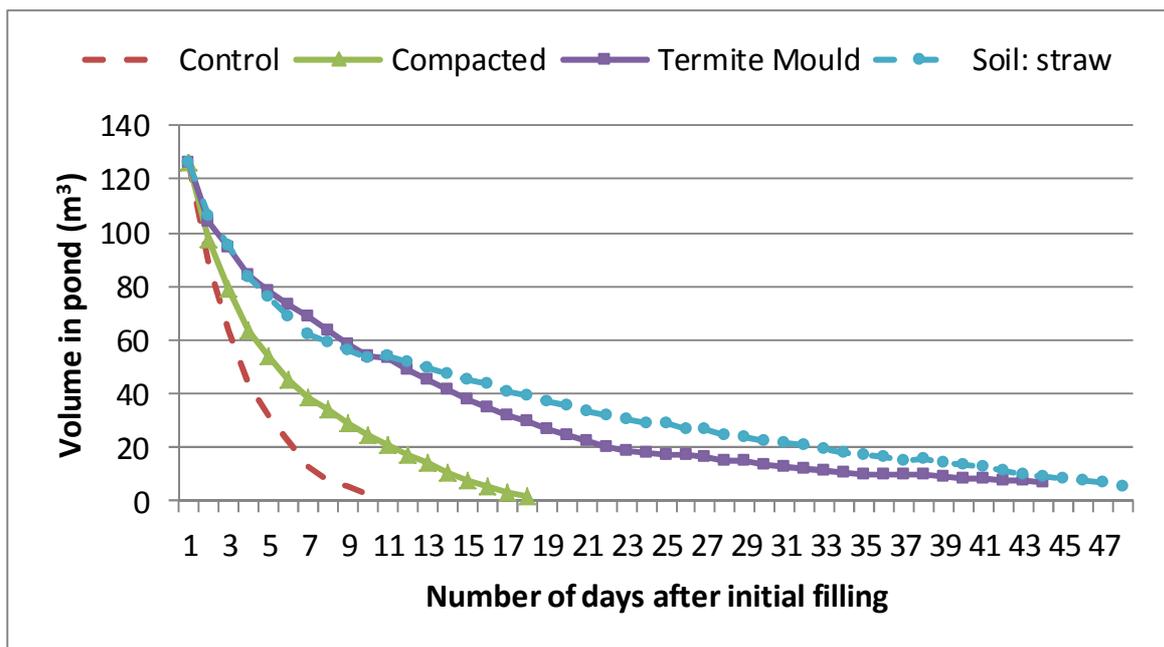
Figure. 4.2 Change in pond volume after filling over 47-day period. (Initial volumes were all at 125 m<sup>3</sup> and a depth of 175 cm.) [Note: There was no recorded rainfall during this period.]

The result of the study is further analyzed to observe the volume of water stored within all four ponds and is shown in Figure 4.2. From this Chart it could be observed that 50% of the water stored could be lost within 4, 7, 15, and 19 days for the control, compaction, termite mound, and soil: straw treatments, respectively. The amount of the water stored in the pond in cubic meter was calculated by multiplying the water depth in the pond and the water surface area.

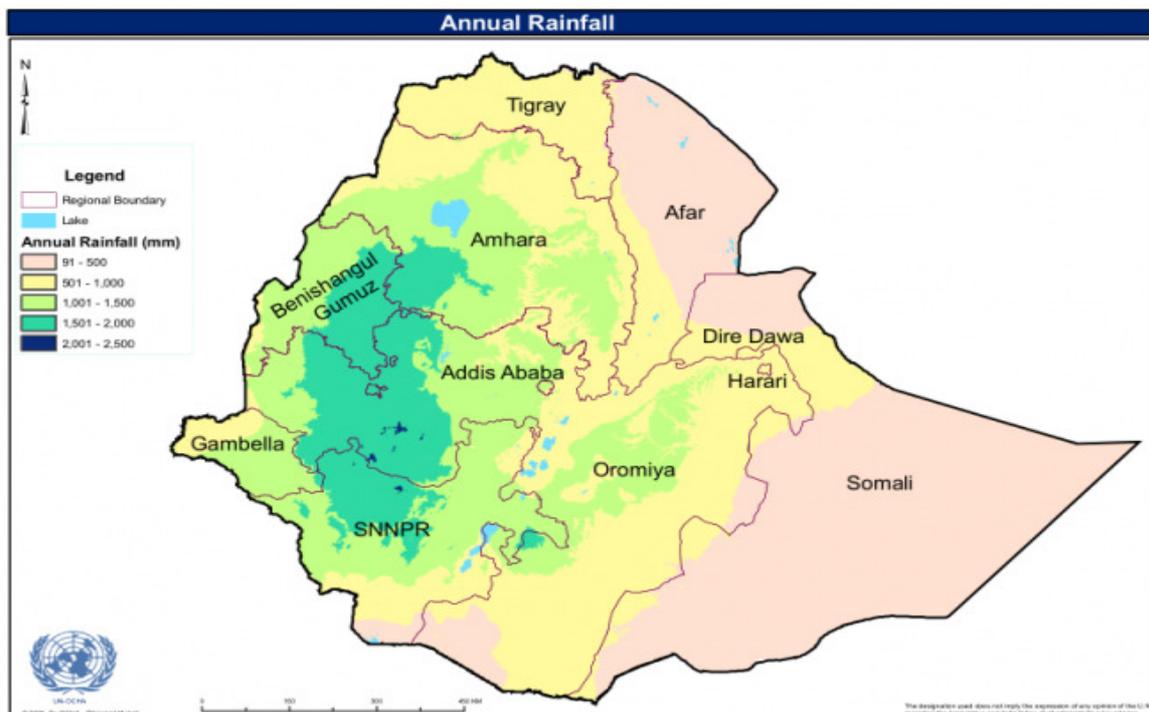
Figure S.1 A rainfall map of Ethiopia. Source: (OCHA 2006)

According to OCHA (2006) (Figure S.1), the Oromia state annual rainfall of 500-1000 mm in central and eastern parts of the region and 1500-2000mm in the western highlands. Oromia region is one of nine regional states in Ethiopia and the central and eastern part of the region is typical of many semi-arid, savannah regions that suffer from recurring droughts due to erratic rainfall. As a result, crop failure is widely encountered, exposing the peasants of the region to food insecurity and forced dependence upon relief assistance following every shortfall of rain. Moreover, climate change predictions suggest that water shortages may increase over longer time spans. Regarding the irrigation development in Oromia region, only 12% of 1.7 million hectares of suitable land has been utilized for surface irrigated agriculture (JICA 2013). FEWS NET (2011) reported that 4.5 million people required emergency humanitarian assistance in a year due to insufficient rainfall and extremely high food prices. To date, the efforts made to trap and store these water resources have seen limited success due to various technical and social problems. The attempts made so far have focused on small-scale water harvesting facilities such as the construction of micro earth dams. This dam is designed as a barrier constructed across a river or stream to create an impoundment of up to 15-meter height from the lowest ground level with a storage
