Assessment of River Shahpur for Flood Risk in Northern Pakistan

Keywords: Flood Risk, Flood Risk Assessment, River Habitat Survey, Spot Check key.

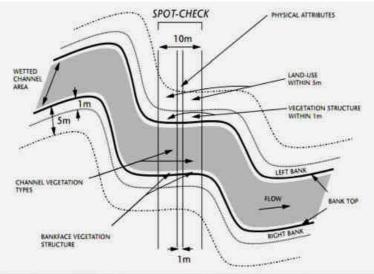
Figure. 1. Spot-check procedure (EA, 1998)

The River Habitat Survey (RHS) method is based on the visual assessment of the stream characteristics. The survey method consists of two parts: ten spot-checks and a sweep-up. Spot-checks were recorded for every 200 meters, where channel features, as well as, right and left bank features were individually assessed (fig.1).

RHS was done through ten spot checks at equal distances and a sweep up of the whole reach. At each spot check the channel, banks and the bank tops are assessed in terms of their physical attributes, land use and vegetation structures. The sweep up assesses the whole reach in terms of land use, bank profiles and the extent of features. The RHS was done by surveying a network of sites chosen as the stratified random sample with the set survey form and recording the results in the database.

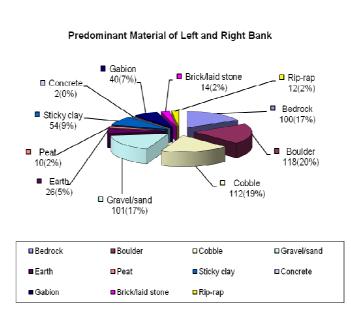
Figure.2. Predominant Material of Left and Right Bank

$Q \propto 1/n$ As n = co-efficient of roughness. Therefore, 57% of the Boulder, Cobble, Sand and Gravel increase the co-efficient of roughness. Thus decrease in discharge at any point is due to increase in roughness co-efficient. A harder crossing the river in its flow, putting impacts on pressure per unit area. Increase in impact causes flow or erosion of sand particles in between gravels and cobbles. Thus erosion is directly related to river side sliding. It also increases the flood damages. Due to the large amount of boulder (BO) and Gravel/Sand (GS) it may also cause the sediment loss.

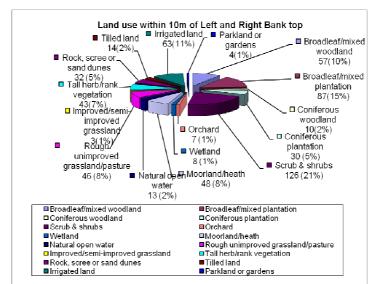
Figure.9 Land-Use within 10m of Bank Top Left and Right Bank

Land-use within 10m of bank top left and right bank include mostly sedimentary rocks and irrigated land. In case of flood the sediment from the sedimentary rocks and irrigated land may loss and irrigated land may completely washouts which will also increases the severity of flooding effect and the environmental pollution may also be increased.

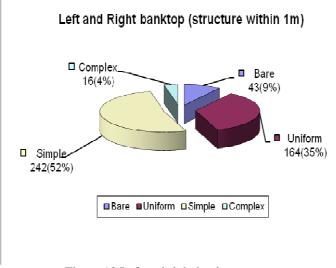
Figure.10 Left and right bank top structure

There is no line of protection (levee) present at lift and right bank top and this will causing high braiding and meandering effects and sometimes river diversion to the valley causing harm to humans, population and property.
