The Existing Challenges of Heritage Management in Gondar World Heritage Sites: A Case Study on Fasil Ghebbi and the Baths

Shegalem Fekadu Mengstie¹

Lecturer at the University of Gondar, Department of History and Heritage Management

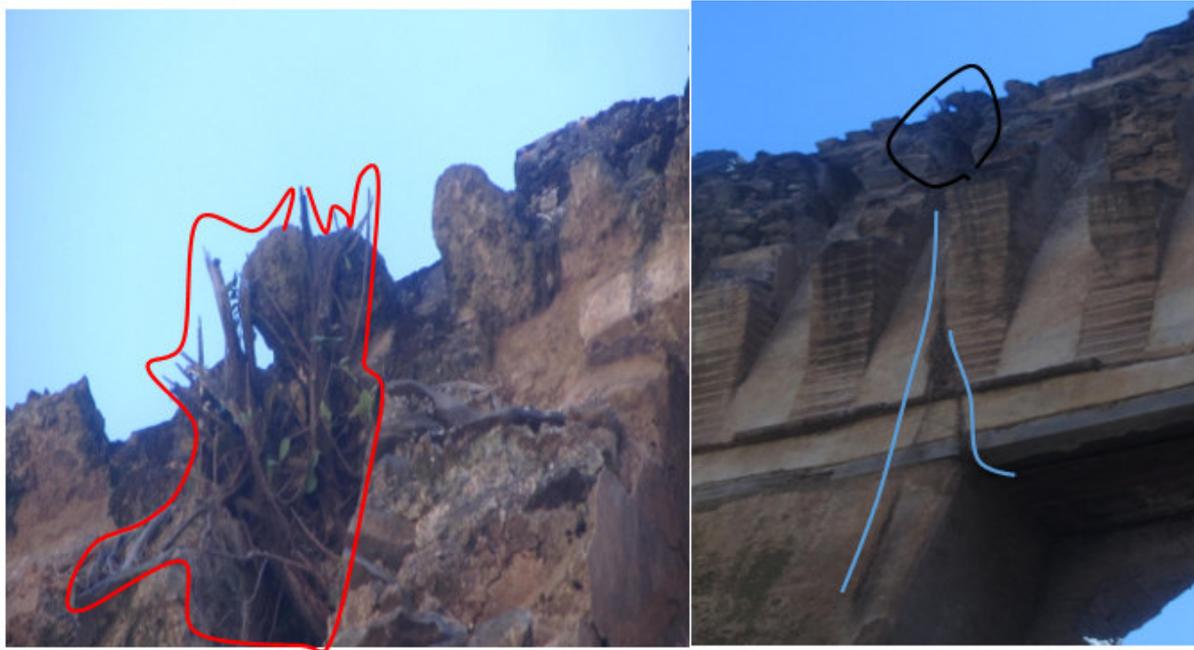
Likewise in Gondar town heritages are the victim of this kind of problem. Large and small trees (shrubs) are grown over historic structures and practically it leads to the destruction of the structures. The small trees and grasses are affecting the structures by creating algae and fungi (Biological agents). These parasites on the structure decayed the wooden materials in the structure. Whereas the large trees grown on the structure became strong through time and their root is go down and then tauten the structure by force when it get strong. This problem is extremely affecting at the enclosure of *Fasil's* bath and palace's of AdiamSegedEyasu.

Fig. 1(A), shows the tree grown on the upper and internal wall of the structure at the southeastern facade of AdiamSegedEyasu's Palace and (B), shows how much the root of the tree (shown at A) go down externally and we can estimate the other part of the root is go deep inside the structure to this much (Photo by the researcher, December 2018).

The small trees and grasses grown on the historic structures should be cleaned and better to have a permanent solution. The solution might be the culture and tourism office shall recruit a person who specializes in heritage conservation to clean and control the heritages permanently. In regarding to the big trees, the researcher strongly recommended to cut the trees before damaging the other part of the structure. Then after reconstruct or restore the structures already damaged through this case.

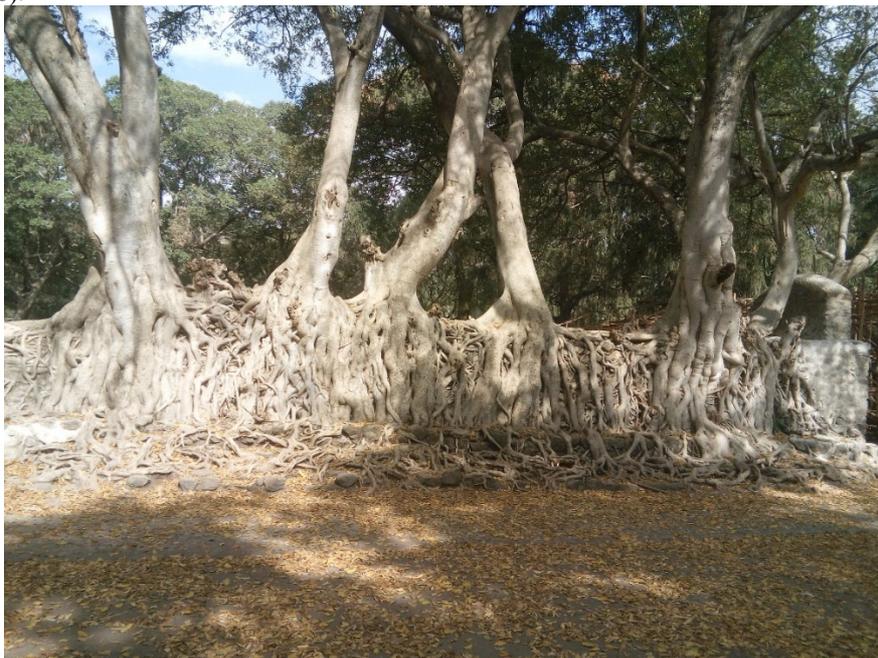
Fig.2, The western external part of the façade of the main bath (photo by the researcher February, 2019)

As we can see on the above image which is the western part of the main bath of *Fasil*, approximately 5m of the historic building is totally demolished by plants grown over it. This means ~5m structure is fully lost by the root of the trees. First it was grown like as the small trees displayed in AdiamSegedEyasu's palace.

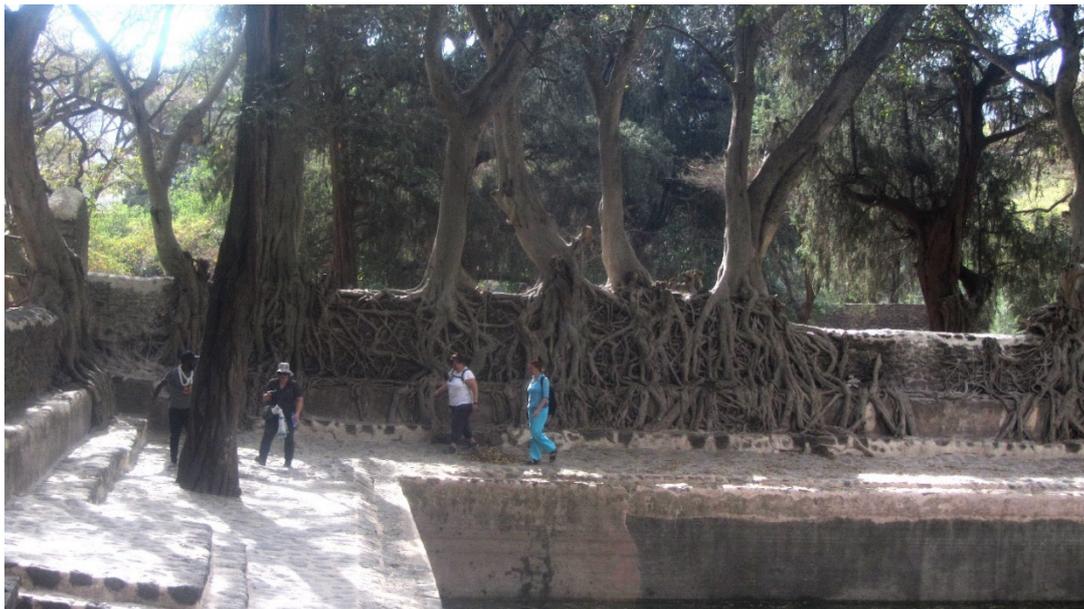
Fig.3 The western external part of façade of the main bath (photo by the researcher February, 2019)

In the external part of the structure the building is totally covered with the root of the trees. Whereas, in the internal part of the structure (fig.3) indicates how the roots are tauten the structure; because the original building is displayed under the roots. In general, plant overgrowth is a common and serious problem of heritages in Gondar town and specifically on heritages in *Fasil Ghebbi* and the baths. There are shrubs, grasses and large trees are grown over the structures almost on every built heritages of Gondar town.

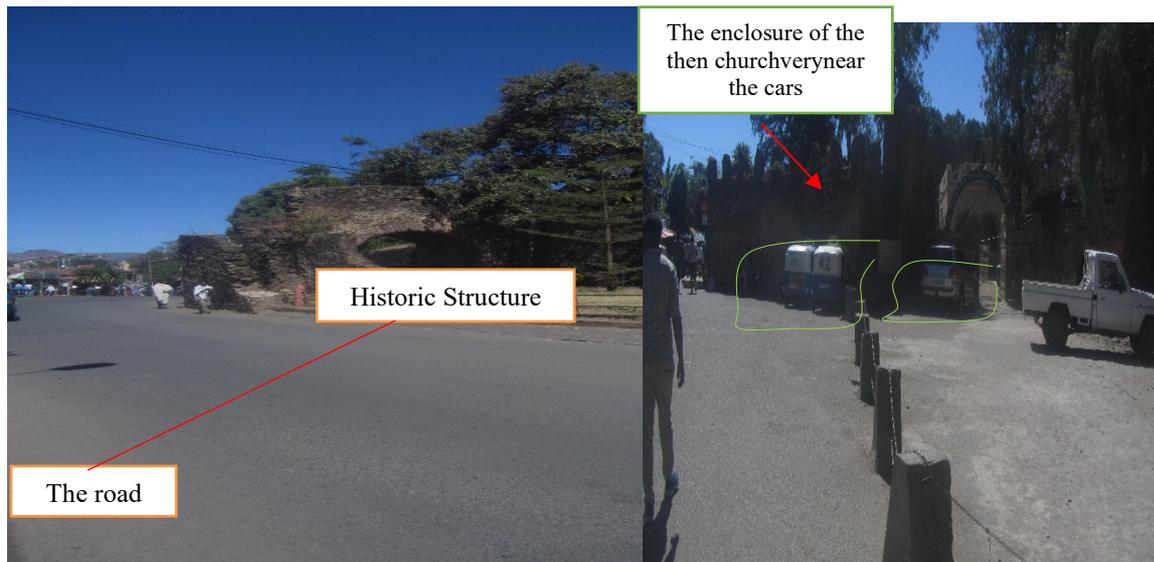
However, in the case of heritages in Gondar (*Fasil Ghebbi* and the baths) they lack these zones or this world heritage management principle is not practicing in action. Due to this, parking, roads, different constructions and squares (different mass activities are performed) are found on the immediate vicinity of all sites. The image below Fig (B) is on the western part or at the exit side of the castles. Cars are parking almost by touching the historic structures (heritages). So, undoubtedly it will destruct the site in different ways. And the image (Fig A) is the heritage/structure which is erected almost on the asphalt road on the side of *Enkoyeber* (south of the castle). It is highly susceptible to car crash and vibration happening by large vans passes through.

Fig.5. the historic structures found almost on the road (A, left), and parking almost by touching the historic structure (B, right) (Photo taken by the researcher, January 2019).

In regarding to roads, squares, parking and other human activities near the site, all the concerned bodies including heritage professionals, municipality and construction offices and culture and tourism office should work together on the this problem. The flow of vans, events on the square, parking almost on the site and cars pass through the historic bridge must be urgently stopped. The settlements almost on the site or nearby and the craps disposed on heritages also needs urgent intervention and stop it. So, the aforementioned stakeholders must introduce a new legislation or law to restrict and stop the human activities that affects the heritage resources.

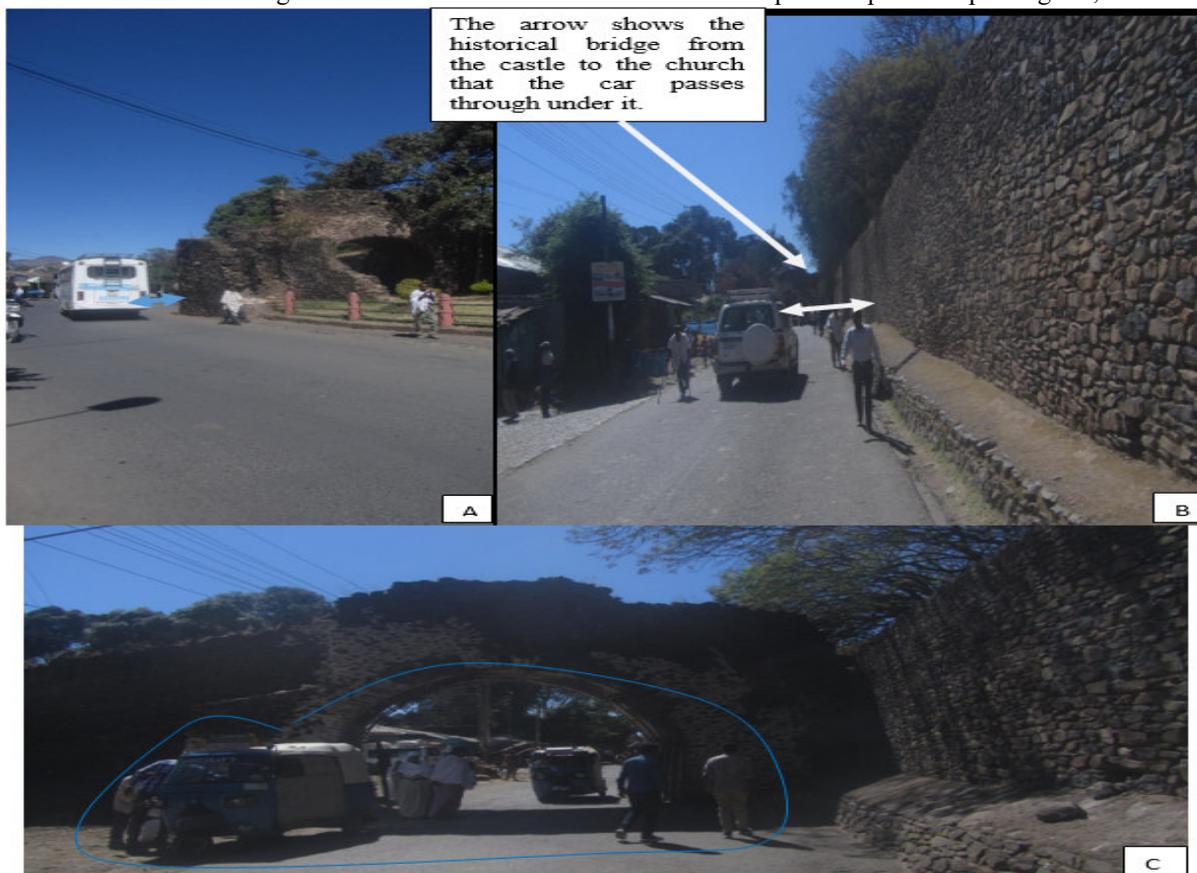
Vibrations resulting from the movement of vehicles around the palace leading to the collapse of the foundations and that needs maintenance and repair (FirasAlawneh, etl. 2012). Similarly, in Gondar town, since the road pass through almost by touching the core area of the site or the enclosure, it makes a vibration when a van passes through the road. And even there is a road under the bridge. This is a serious problem and even the case will make the site under endangered list. As we have seen above there is no specified place for parking. So, in most

Fig.6 a large bus passes near the historic structure (A), a car that will passes through the historic bridge displayed below there (B) and the bridge over the road and activities under it (Photo by the researcher, January 2019).

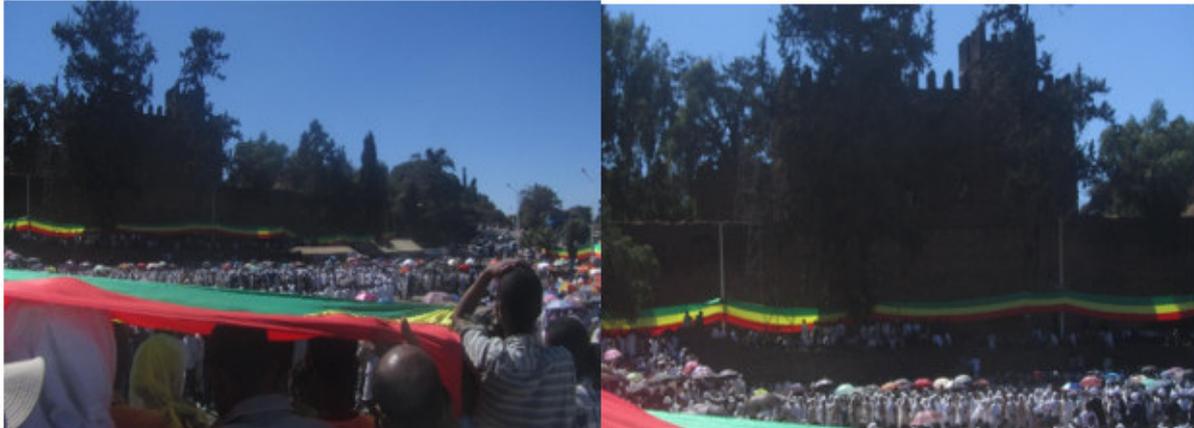
Fig.7 the event prepared on the square which is under the *Fasil Ghebbi* when an exile bishop (Abune Merqoreyos) came to the town (Photo taken by the researcher, January 2019).

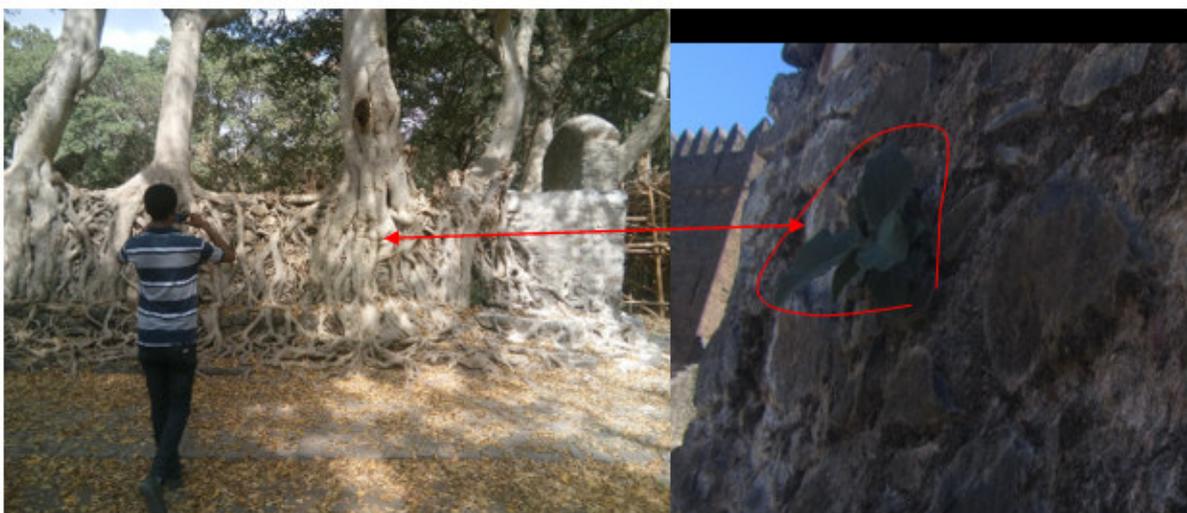
Even, the growing of large trees on the structure is the result of carelessness or negligence. As we can see the image below (the readers' right side) trees on the structure grown like that and through time it destruct like the image below displayed on the left side. It is simple to avoid the small trees before they get strong except carelessness/ lack of due attention towards the heritage site.

Fig.8 the structure destructed by big trees at *Fasil* bath and a small tree growing on the left side of the stair goes to the second floor of *Fasil* palace (Photo by the researcher, January 2019).

Professionals and concerned institutions must give a due attention for the neglected heritages. The researcher believes that, the public bath located above the *Fasil* bath needs archaeological excavation and the institutions should work in relocation of settlements over the baths.

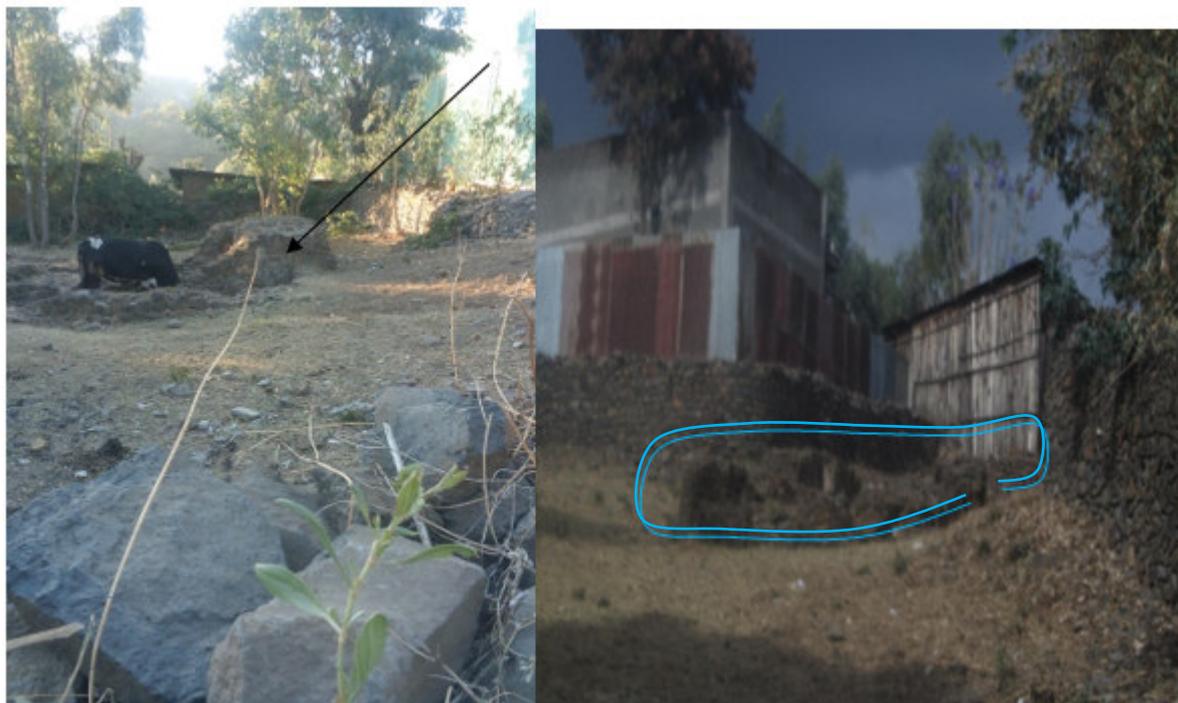
severely neglected. The structures are destructing and almost buried with craps. The peoples living there are damping sweepings/dusts on the historic structures. Plants overgrown, herding animals and settlement inside the enclosure of the sites are destructing the heritages. The following figure shows the ruins of the public baths which was used as hen breeding during the Italian occupation period (1935-1941).

Fig.9 a circle of ruined structure buried through the accumulation of craps and now a cow is eating a grass in the circle of the structure. This shows how much the historic structure is neglected (reader's left). And the other ruin of a structure which was a public bath and now a new house is constructed over it. The new settlement almost covered the site (reader's right (Photo by the researcher, February 2019).

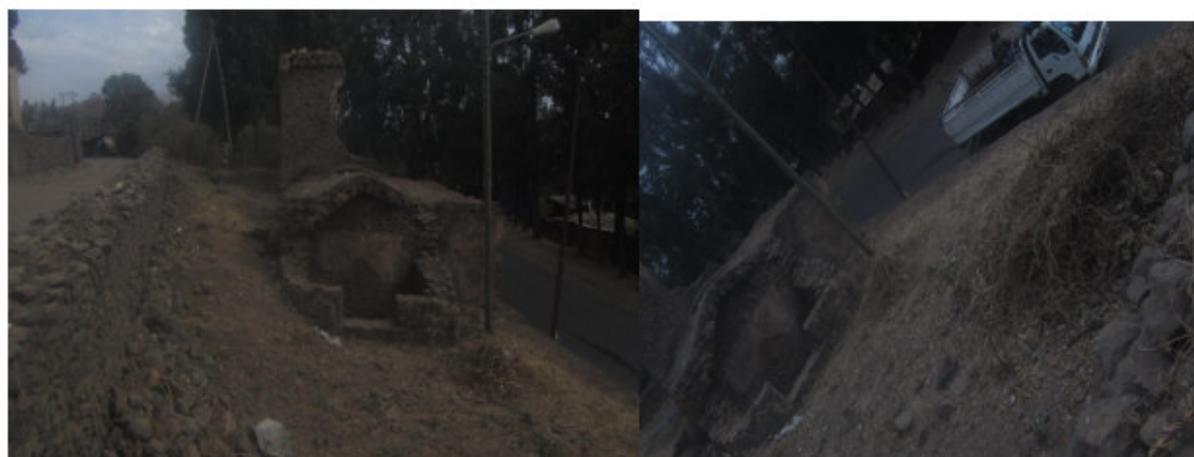
Fig. 10 it is also the ruin which was the public bath during the reign of emperor *Fasil*. And as we can see on the image, it is almost destruct and the compound is full of craps. Roads also encircle the structure in two directions (reader's left). And the right image also shows when the big van passes almost close to the site (reader's right) (Photo by the researcher, February 2019).

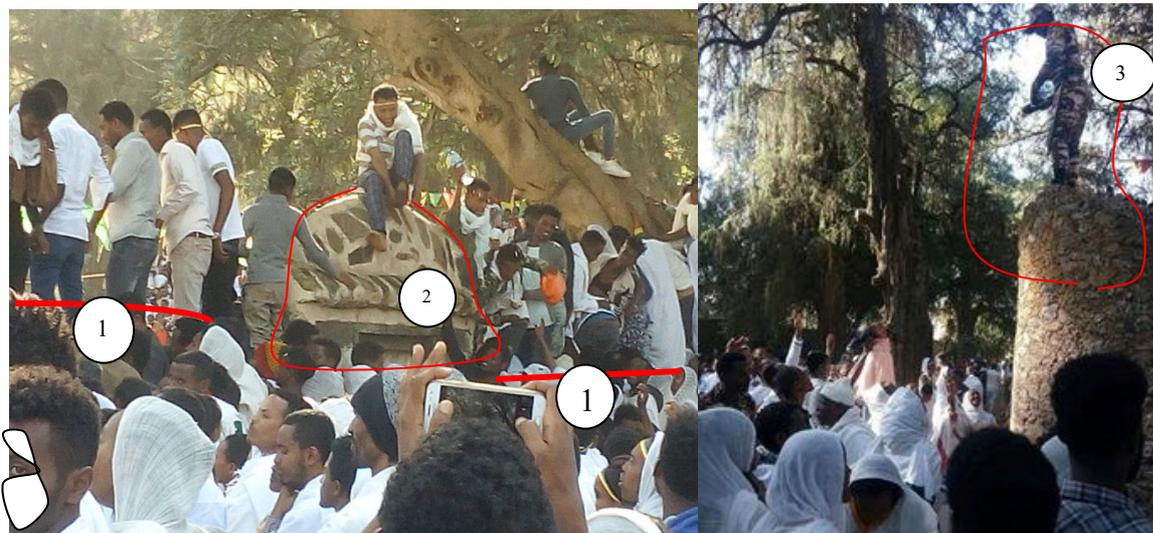
In case of heritages in Gondar, particularly the domestic tourists who came in group pressurize the sites. Mostly ground plus heritages with wooden floors are seriously damaged. For example, during epiphany celebration domestic mass tourism is highly affecting heritages. As we can see on the image below all the peoples are standing and crowded over the structures of the *Fasil* bath. Certainly, it leads to crack, distort and removal of the structure.

Fig.11 Peoples are standing on the historic structure of the bath during epiphany (1), a guy wearing his shoe after baptizing on the peak of the arched door (2) and a soldier also standing on the historic structure and “baptizing” the people (3) (Photo by the researcher, January 2019).

A number of visitors in a time should be specified or restricted. As it is stated in the main body, the domestic tourism including number of visitors during wedding should be restrict. During epiphany and other events, it is better to have a way that accommodates the visitors without affecting the site.

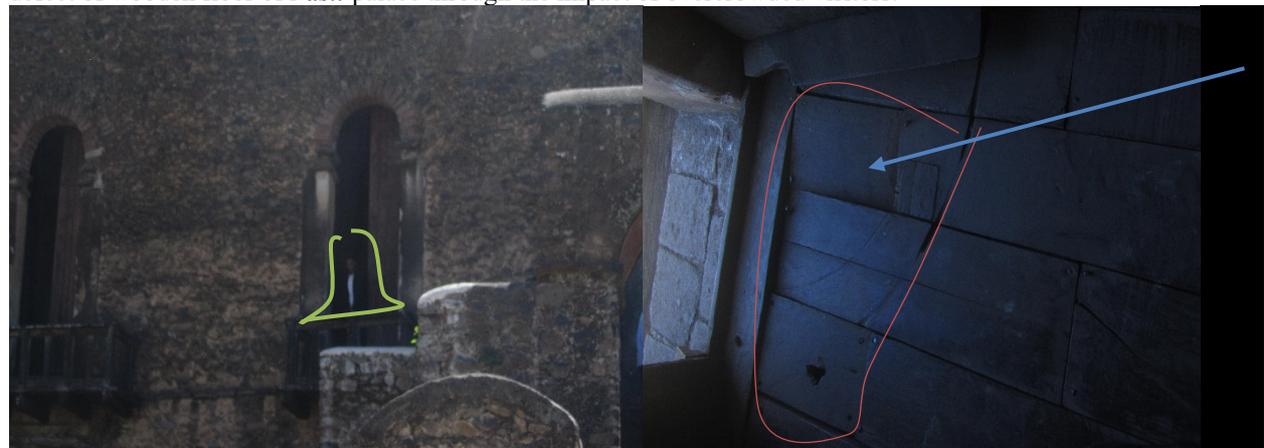
The following image is the second example for how mass tourism challenging heritages in Gondar town. The left photo (A) shows as a person standing for photo on the space at the back side of *Fasil* palace made out of wood. During the frequent visit of the researchers they saw this trend of having photo on this place. So, this trend on the wooden historical structure is a treat for its destruction. The image on the rightside; (B) also shows the defect of wooden floor of *Fasil* palace through the impact of overcrowded visitors.

Fig. 12(A), a person standing on the historical wooden structure to have a photo at the back side of the castle of *Fasil* and (B), the wooden floor of *Fasil* palace and the circle show the defect of the floor.

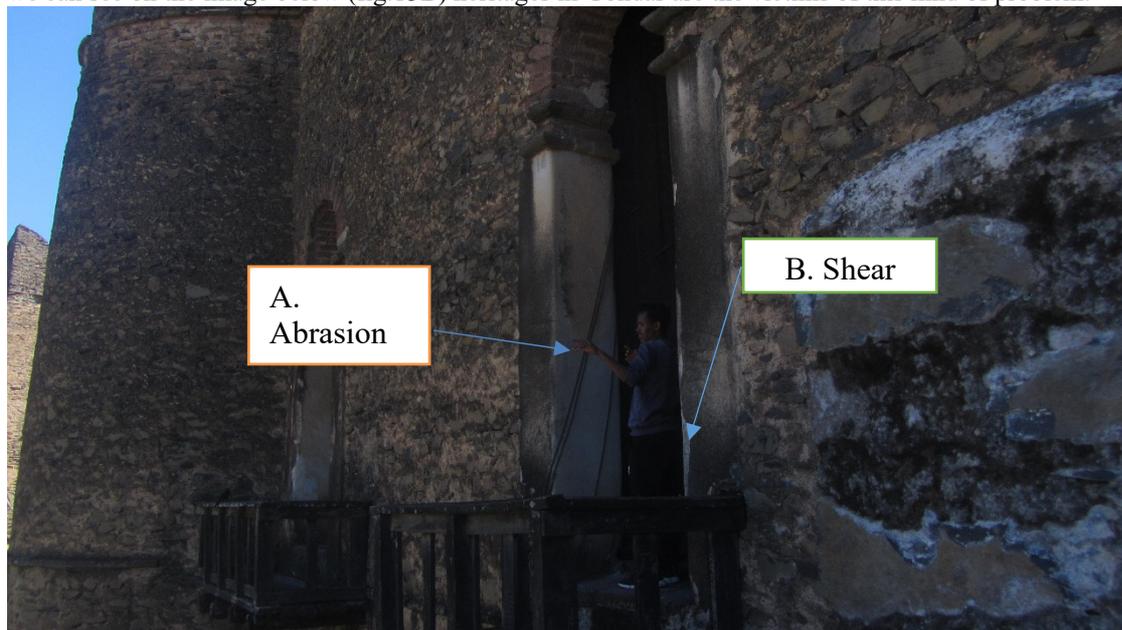
Beside of the above stated problems resulting from visitors' pressure, it also leads to abrasion and shear of the structures. Abrasion is the fading up of structure through touching and removing the plaster over the wall by hand. In *Fasil* castle, all the frames of the door, the window and even the wall are damaging through abrasion

(see Fig.13 A), whereas, shear is the removal of the parts of the structure in time through frequent uses. So, as we can see on the image below (fig.13B) heritages in Gondar are the victims of this kind of problem.

Fig 13(A.), Abrasion of the structure at *Fasil* palace and (B), shear of the structure at the same place.

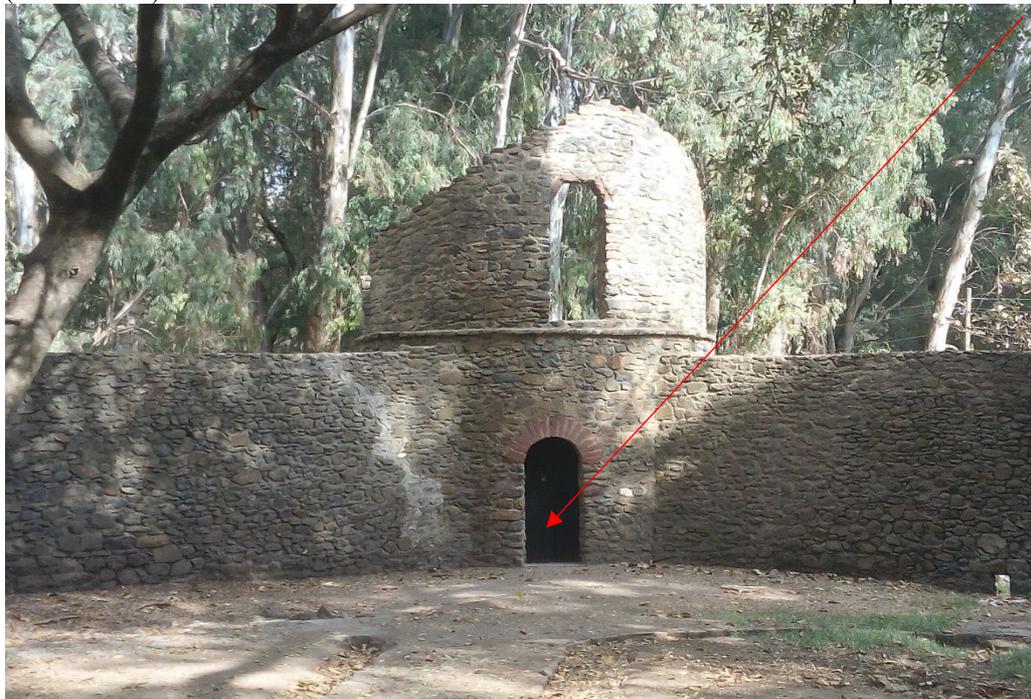
Fig. 14 the guard house found on the south of the bath (Photo by the researcher February, 2019)

The above displayed guard house was constructed in the south of the *Fasil* bath for guarding purpose and it is attached with the external fence of the bath. But now it is changed in to toilet. During the researcher's survey it was locked (as the arrow showed on the image) and according to the guard, it is locked due to the lack of water.

According to the above argument, adaptive reuse is self-defeating if it fails to protect the building's heritage values. This means the developer should not disturb or change the heritage value of the historic structure. It is also advisable when adaptive reuse of a building is the only way to sustain the building and should not be a problem for the environmental settings. However, in the case of *Fasil's* bath guard house is now changed to toilet. That means the original value of the guard house is totally changed. And the new function of the house by itself is destructive for the heritage and disturbs the surrounding environment. So, the work is done in contradict with the principle of adaptive reuse.

Conservation work should not be in contradicted with its science or should not be destructive. Conservators shall consult the professionals in the area. In the case of the adaptive re-use at *Fasil* bath all the materials for the installation of toilet in a historic structure should out and make it free or better to adapt and reuse for non-destructive purpose.

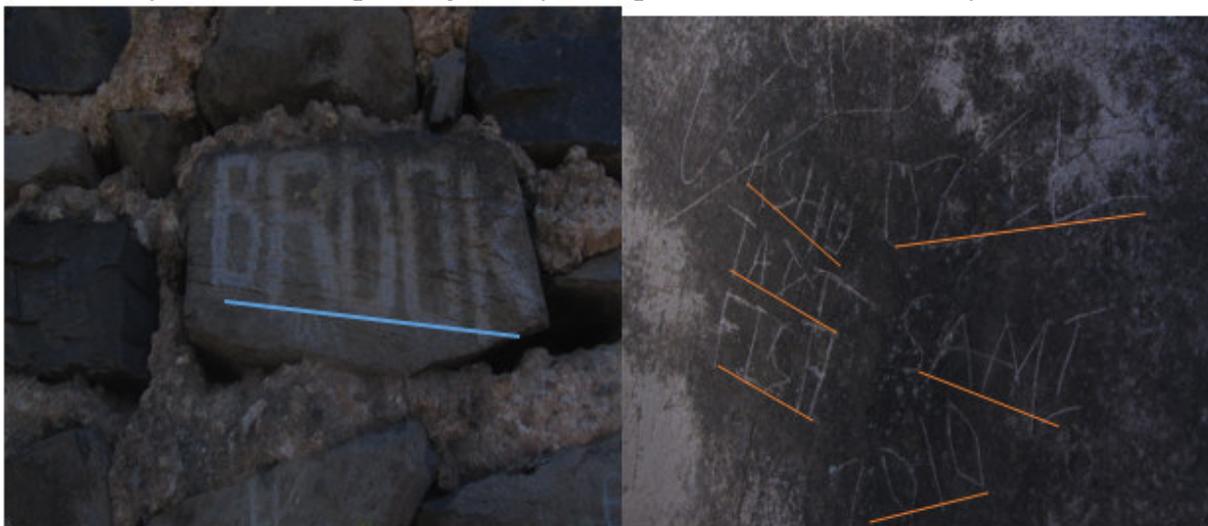
In the case of heritages in Gondar town, except selling of tickets at the entrances; no follow up of tourists after they enter to the enclosure. Particularly in the castles, no body follow-up the visitors; what they are doing inside. Due to this problem visitors made a graffiti (strike and incise) on the wall and write their name and sign their signature on the wall. As we can see on the image below, the names written with strike strongly spoiled/damaged the surface of the wall. The image shown at “C” is the name written on the wooden part of the wall. So, this problem is affecting not only on the plastering wall, but also on the wooden part of the structure.

Fig15. .A. Strike and written name(BROOK) on the external wall of the then archival center B. Strike and names (ASHU, OZIL, TADI, SAMI, FISH and ZOLO) of the visitors on the plastering of eternal wall of the Fasil bath

Tourist-follow up system also mandatory and it might be in the form of installing a hidden camera or follow up the visitors in person. In doing so, we can minimize or avoid illegal activities inside the sites by the visitors who visit the site without guide.

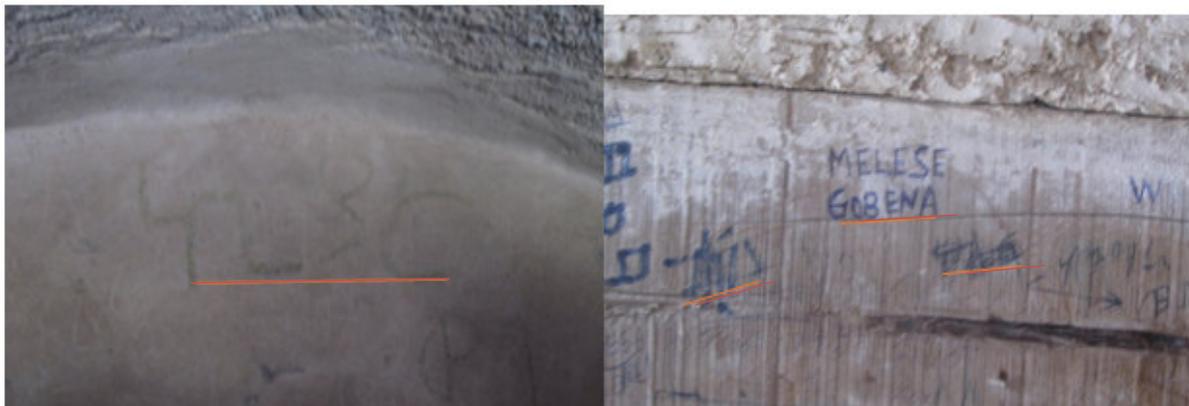
C. Written name (ሲያር) by striking on the plastering ceiling of the bathe of *FasilGehebbi* and D. Again strike, written names (MELESE GOBENA) and signatures on the eternal ceiling of Emperor Bakafa's castle (Photo by the researcher, December 2018).

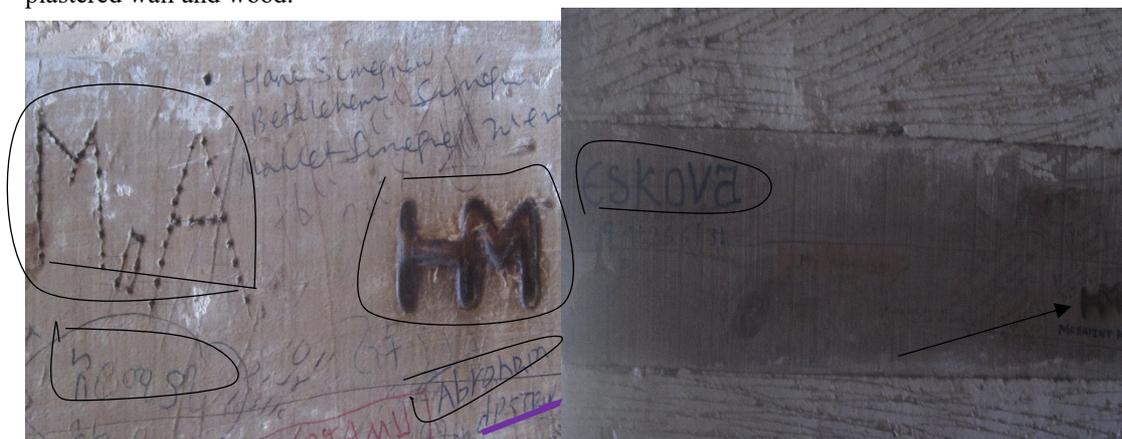
Beside of the strikes stated and shown above, incised on the wooden part of the structures also another issue which is a threat for the heritages in Gondar town resulting through failing to follow-up visitors during their visit. The image below (A&B) shown on the encircled and arrow indicates that visitors are incised their names on the plastered wall and wood.

Fig.16 A. Names and abbreviations incised on the plastered surface of the eternal wall of emperor Bakafa's palace and B. The abbreviation (HM) shown by the arrow incised on the wooden part of the same palace with figure A.

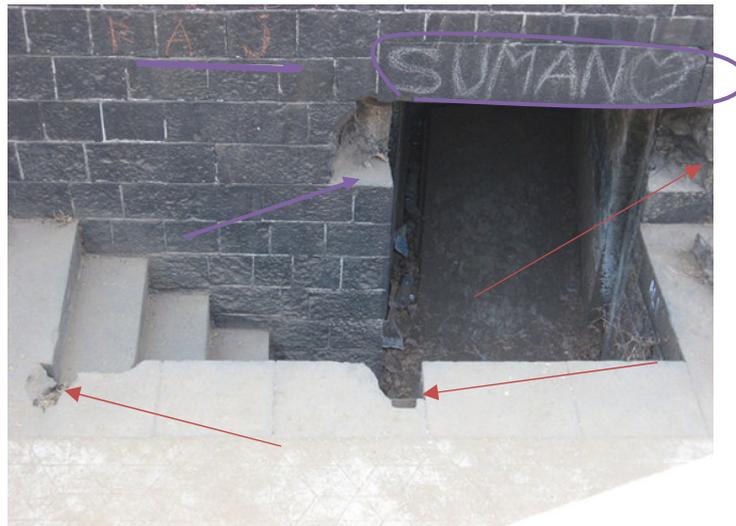
Unfortunately, visitor mistreatment of the caves and their sculptures goes back many centuries. The Portuguese used the sculptures as target practice during the 17th century, and subsequent colonial regimes treated the ancient masterpieces little better. While the modern state of India has more respect for the sacred nature and value of these temples, Elephanta's close proximity to Mumbai and international reputation as a masterpiece has made for an unsustainable level of tourism. Very little conservation work or effective crowd control has been conducted by the authorities; as a result the already-damaged sculptures are in grave danger of further degradation.

Fig. 17 Photo of graffiti at Elephanta caves tunnel (taken from John Mink, 2009 available online)
