# Geophysical Investigation of the Causes of Borehole Failure in the Crystalline Basement Complex: A Case Study of Kaura Area of Kaduna State, Nigeria

## Abstract

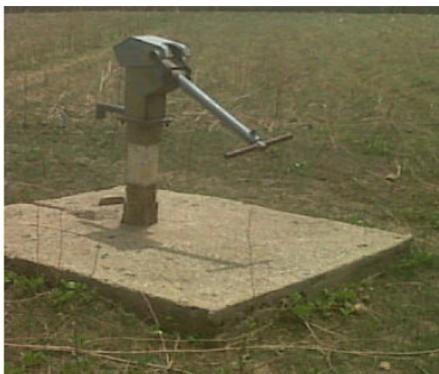
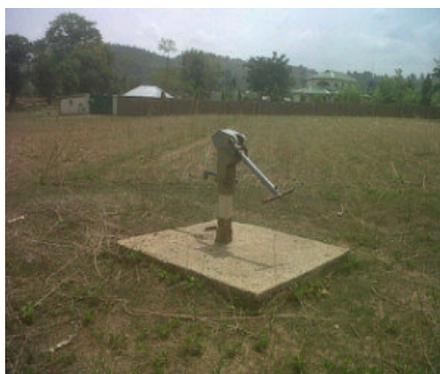
*Plate1. Picture of non-functional boreholes in the study Area.*

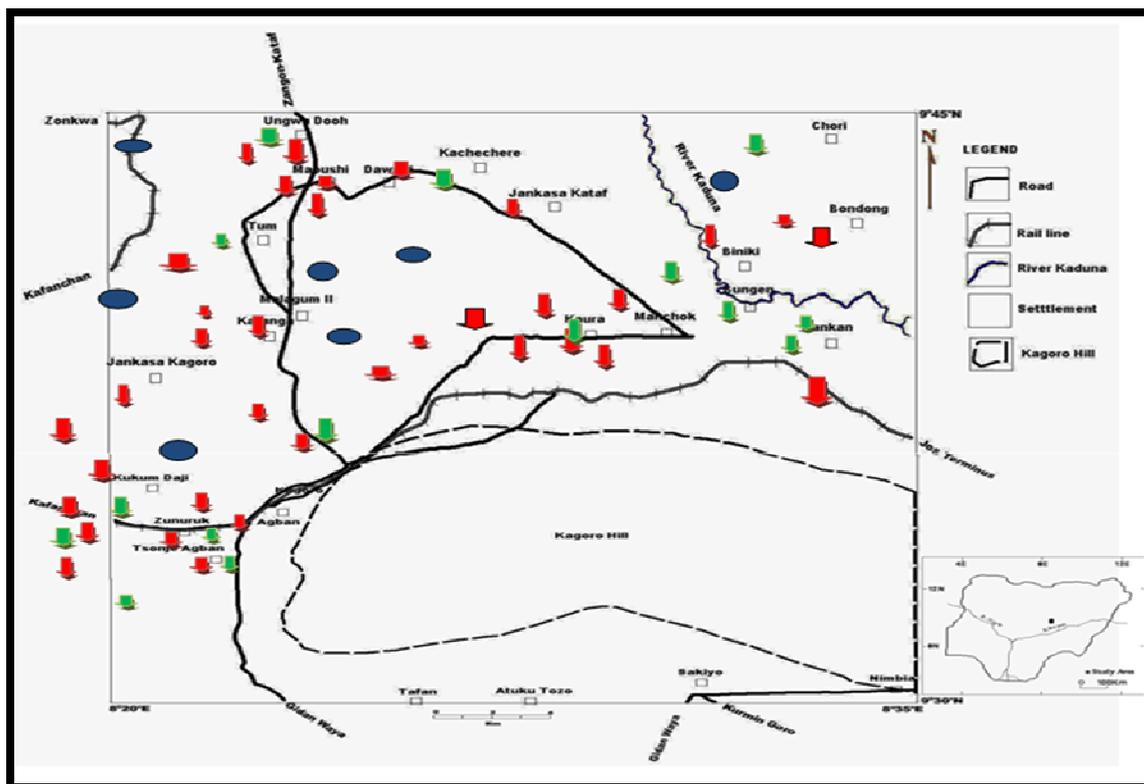
*Figure2. Map of Kaura showing the functional (coloured green) and non-functional boreholes (coloured red).*

There are fifty (50) boreholes within the survey area (Figure2). Out of the total of 50 schemes inspected, 19 are mechanized with submersible pumps, while 31 were fitted with hand pumps. A total of 15 boreholes are functioning, while 35 boreholes are non-functioning.

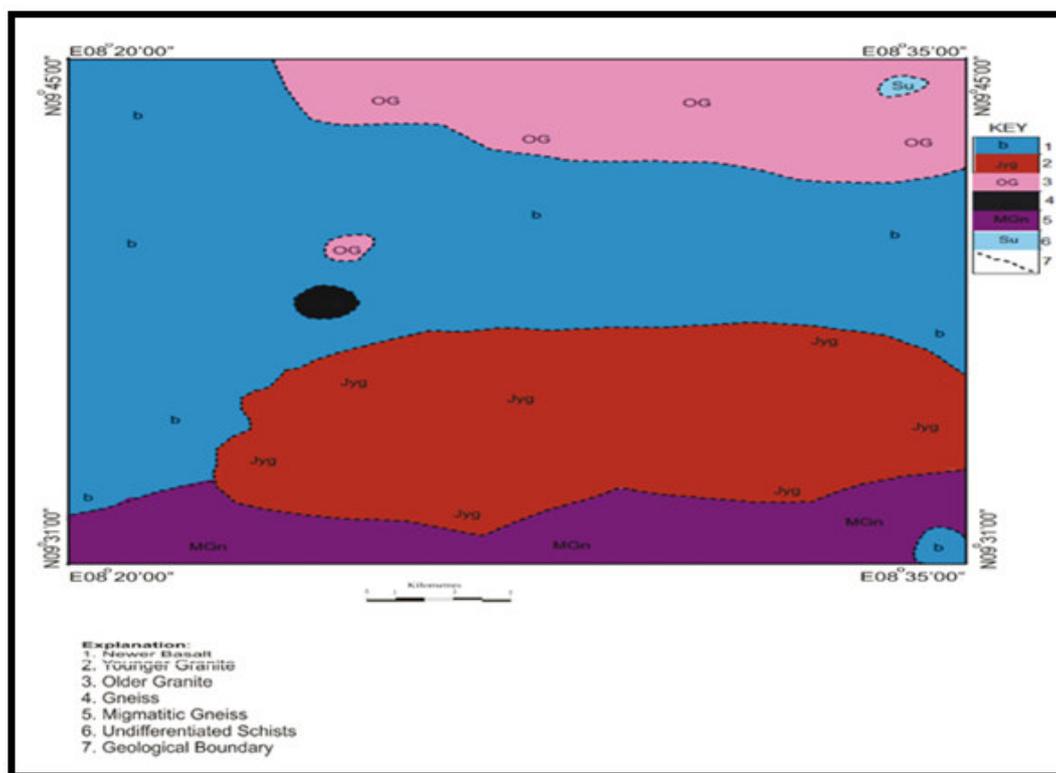
Figure3. Geological map of the Kaura.

The study area is made up of the rocks of the Migmatite-Gneiss Complex, Gneiss, Younger Metasediments, Older Granites, Younger Granites and Newer Basalts. The distribution of the various rock types is as shown on the geological map of the area (Figure 3). Basement rocks that occur in the study area could be classified into:

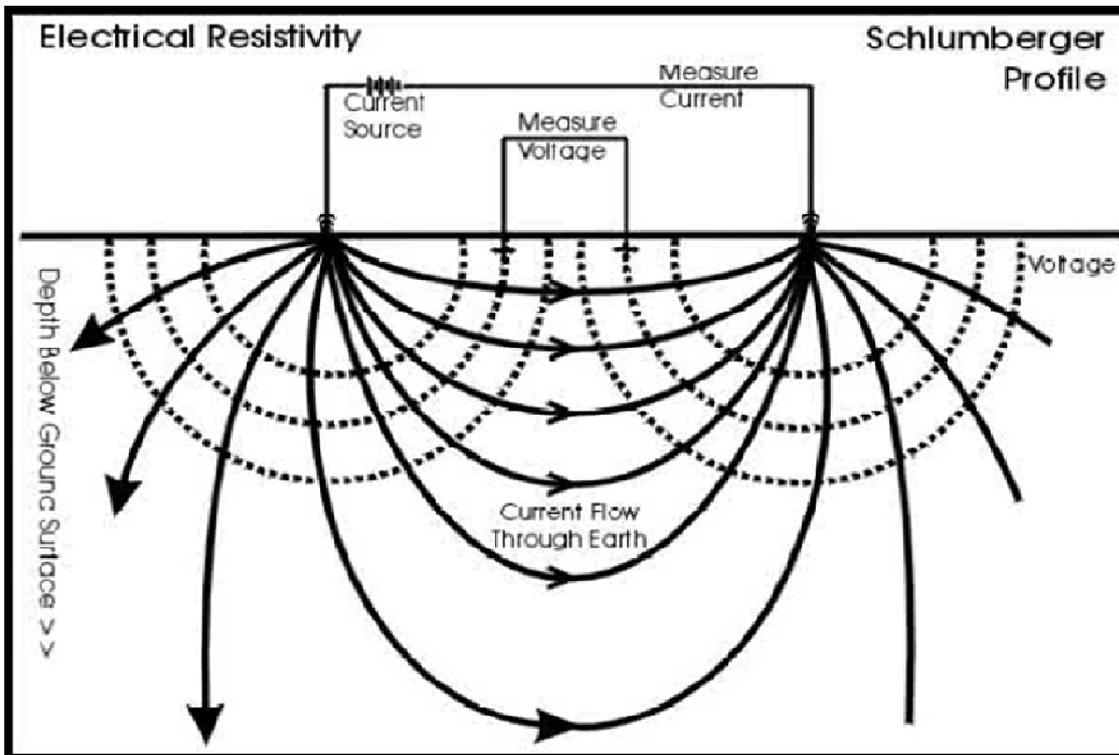
Figure4. The Full-Schlumberger Array

The method of study includes geophysical investigation using resistivity method and analysis of records on boreholes located within the area. In the DC resistivity surveying, using the Schlumberger array (figure4), an electric current is passed into the ground through two outer electrodes (current electrodes), and the resultant potential difference is measured across two inner electrodes (potential electrodes) that are arranged in a straight line, symmetrically about a centre point. The ratio of the potential difference to the current is displayed by the Terrameter as resistance. A geometric factor (G) in metres is calculated as a function of the electrode spacing. The resistance reading obtained by the Terrameter is multiplied by this factor to give an apparent resistivity value. The electrode spacing is progressively increased, keeping the centre point of the electrode array fixed. Schlumberger arrays are relatively sensitive to vertical variations in the subsurface resistivity below the centre of the array but less sensitive to horizontal variations in the subsurface resistivity (Barker, 2001). The arrays have moderate depths of investigation and generally strong signal strength which is inversely proportional to the geometric factor used in calculating the apparent resistivity values (Afuwai, 2014). The major limitation of these arrays is the relatively poor horizontal coverage with increased electrode spacing.

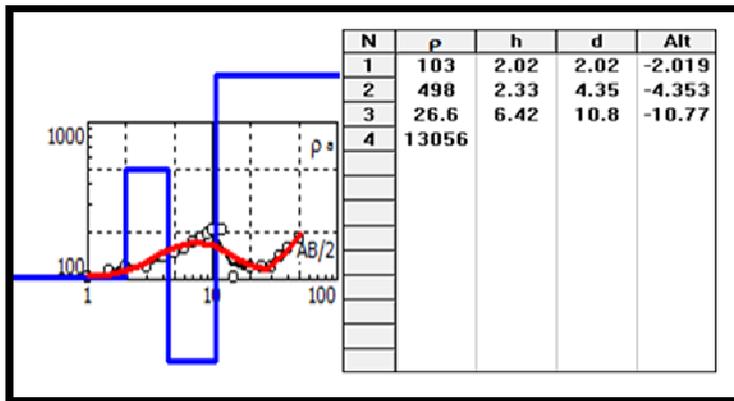
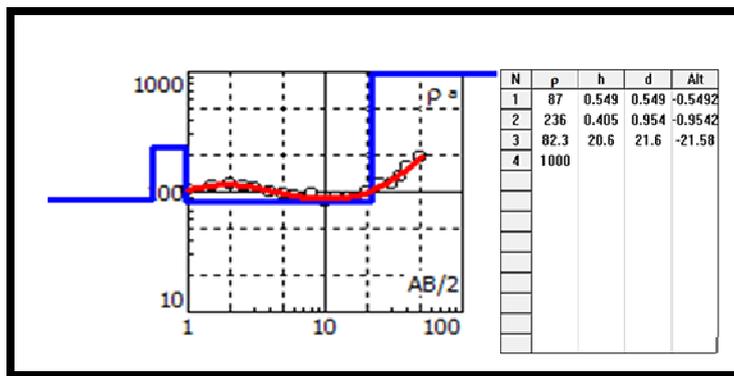
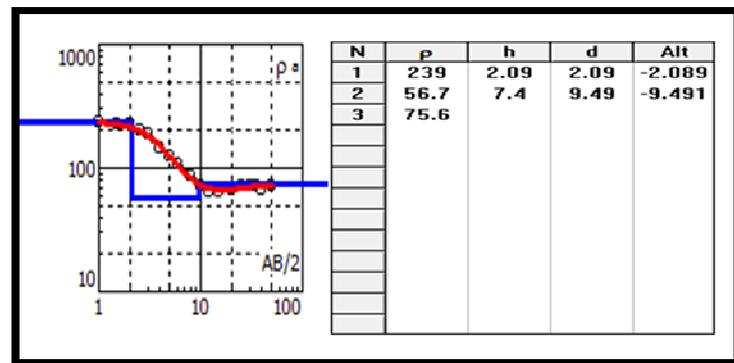
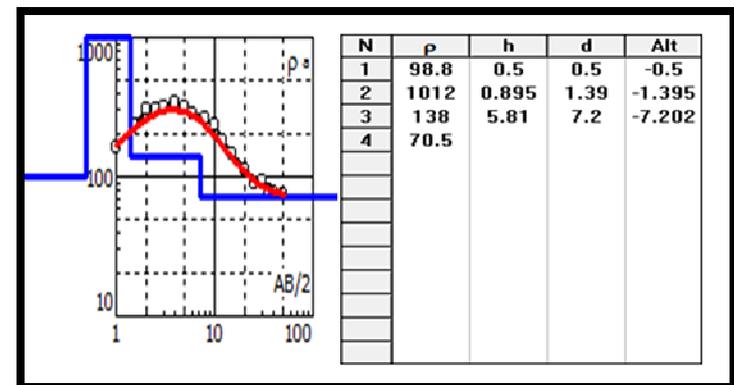
Based on the IPI2Win's method, the field curves were found to be averagely four layers (figure5). Below are

Figure5. Samples of VES curves and interpretations obtained in the survey. Most of the curves show four layer models consisting of the subdivided regolith layer and the basement rock

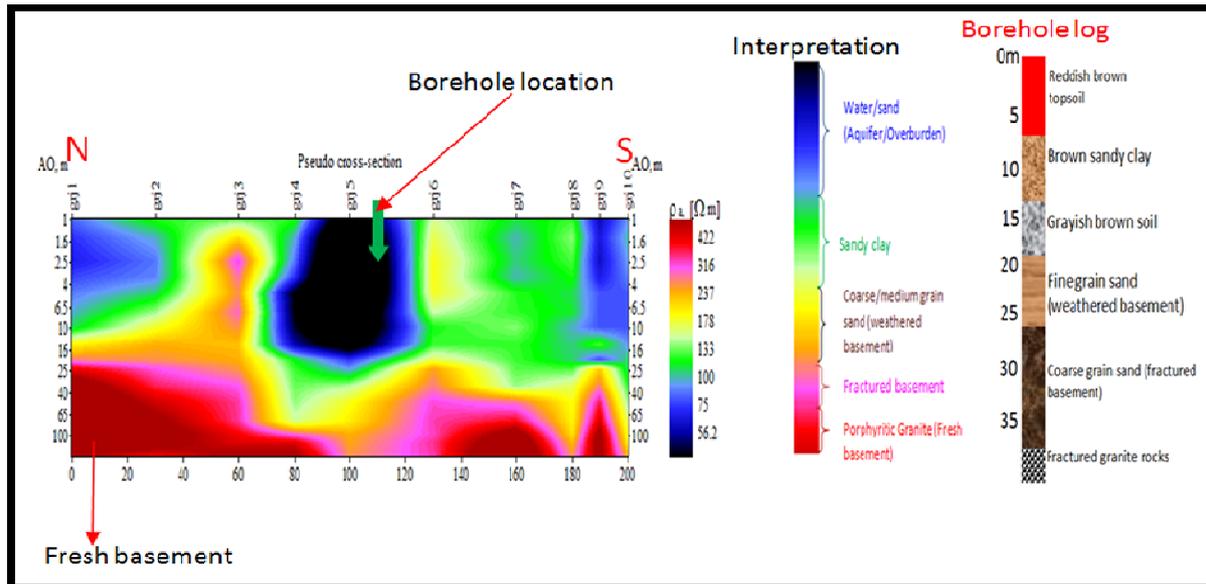
**The Borehole is functional.** A total of ten (10) VES Points were sounded along a profile of 200m length in the N-S direction across the Borehole location. The Borehole was constructed in the year 2005; it was drilled to a depth of 42m. The recorded sufficient yield of the borehole at the point of commissioning was 15litre/min (KSWB, 2006) which is above the minimum guideline value for a successful borehole. The Pseudo section shows that along the Profile where the borehole is located has an aquifer with thickness of approximately 60m (Figure6). The overburden with a resistivity range of 50-140Ωm constitutes of wet brown sand and sandy clay which correlates well with the borehole log. The weathered basement which is the second layer constitutes of coarse/medium grain sand which slightly differs from that of the Borehole log which is fine grain sand. The resistivity value of the weathered basement layer ranges from 100-250Ωm. The depth to basement varies along the profile; however, averagely it is about 65m. Generally, the geophysical results revealed that the high yielding aquifer is a heterogeneous unconfined aquifer with a good yielding potential which have thick overburden deposition of weathered sand.

**Figure6: Resistivity tomography section for Garaje Profile.**

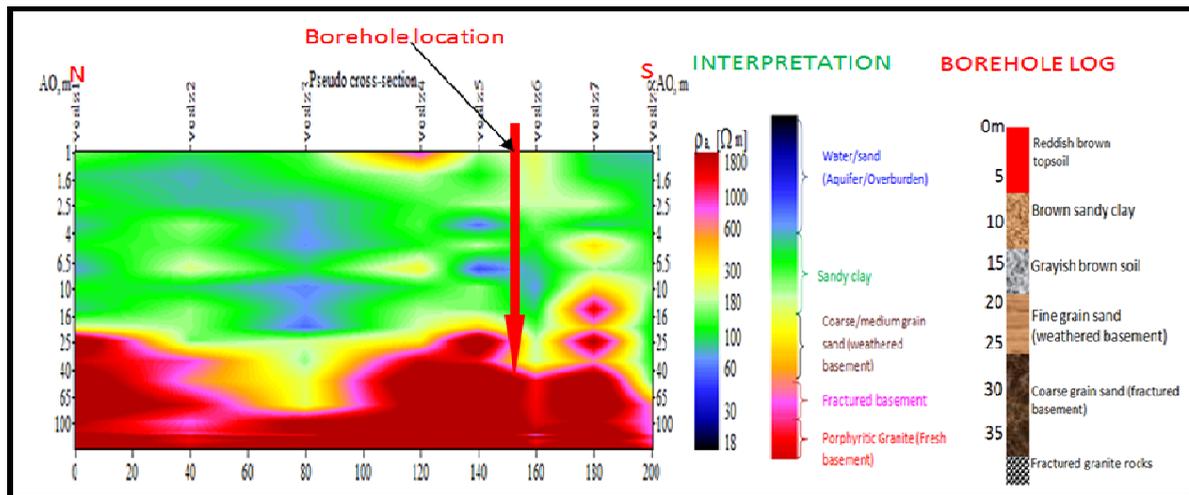
The Borehole at LGEA Zakwa is located at a latitude of 09°36'35.04"N and longitude of 08°19'31.62"E. **The Borehole is non-functional.** A total of eight (8) VES Points were sounded along a profile of 200m length in the N-S direction across the Borehole location. The Borehole was constructed by Kaduna State Water Board (KSWB) in the year 1998; it was drilled to a depth of 36m. The recorded initial yield of the borehole at the point of commissioning was 9.5litre/min (KSWB, 2006) which is slightly below the minimum guideline value for a successful borehole. The Pseudo section of this profile (figure7) shows a top layer resistivity value range of 100-1000 Ωm. This variation in the resistivity value from one point to another along the profile is an indication that the degree of weathering of the area varies within the subsurface and also may composed of partly saturated but compacted materials. This layer is underlain by a homogenous low resistivity layer (100Ω m to 180Ωm) at a depth ranging from approximately 4m at the southern part of the profile to about 16m to the northern part. The layer is interpreted as rich in clay. This clay which characterized the layer is a poor aquifer. This suggests that the borehole was drilled through clayey formation which is prone to seasonal volumetric changes (Sands, 2002). Therefore the degree to which a soil expands or contracts is a critical cost factor, particularly for the Borehole sustainability. The clay soil shown on the section occurs at various levels of consolidation. This is in agreement with the interpretation provided in the Borehole log which suggests that the depths to which the borehole is sited are clayey and that the clay formation is significantly active. According to Egwuonwu et al. (2012) and the Council for Geosciences, South Africa (2006), moisture changes lead to swelling and shrinkage of clays, and affect shallow boreholes and foundation of buildings. It has been stated earlier that the Borehole was drilled to a depth of 36m with an initial yield of 9.5litre/min which is relatively shallow and low to sustain the Borehole. Towards the base of the clayey zone (approximately 46m deep), near the fresh basement interface, the proportion of clay significantly reduces. This horizon, which consists of fractured rock, is often permeable, allowing water to move freely. Wells or boreholes that penetrate this horizon can usually provide sufficient water. These facts suggest that the active clayey soils, insufficient depth of drilling and low initial yield most probably have contributed to the failure of the borehole.

Figure7: Resistivity tomography section for LGEA Zakwa Profile

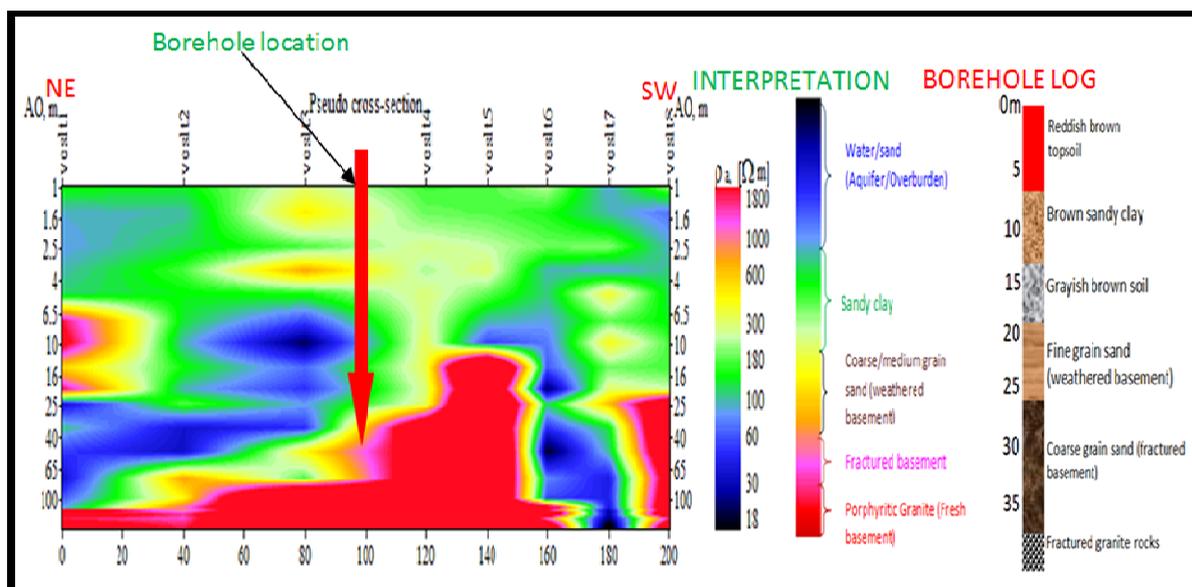
The Borehole at LGEA Techarak Primary School is located at latitude of  $09^{\circ}38'28.92''N$  and longitude of  $08^{\circ}26'24.42''E$ . The borehole is non-functional. It was drilled to a depth of 25m, the initial recorded yield was 8litre/min and the static water level was 10m (Yanet, 1996). The borehole was drilled by National livestock development project, Kaduna. Eight (8) VES Points were sounded along the Techarak Profile of 200m length. The calculated apparent resistivities of these VES Points are then inverted using the IPI2win+IP software to produce a tomogram of the profile. The image (figure8) produce shows that the underlying layers where the borehole was drilled is predominantly clay and of sand/water. Generally, the subsurface structures as shown on the tomogram seem to be highly weathered. The borehole most have failed because it was drilled through a clayey layer of resistivity range of 100-300Ωm. Other factors may include hydrogeological failures due to the problems of boreholes tapping aquicludes and seasonal water level fluctuations (Afuwai et al., 2013). This could result from poor siting of a borehole due to the absence of proper pre-drilling investigations. The problem of water level fluctuations in aquifers arise when over-pumping may result in dynamic water levels dropping below the pump intake, leading to temporary failures. This situation is quite common when borehole drilled in the basement complex terminate only at the overburden without tapping the fractured basement rocks.

Figure8: Resistivity tomography section for LGEA Techarak Profile

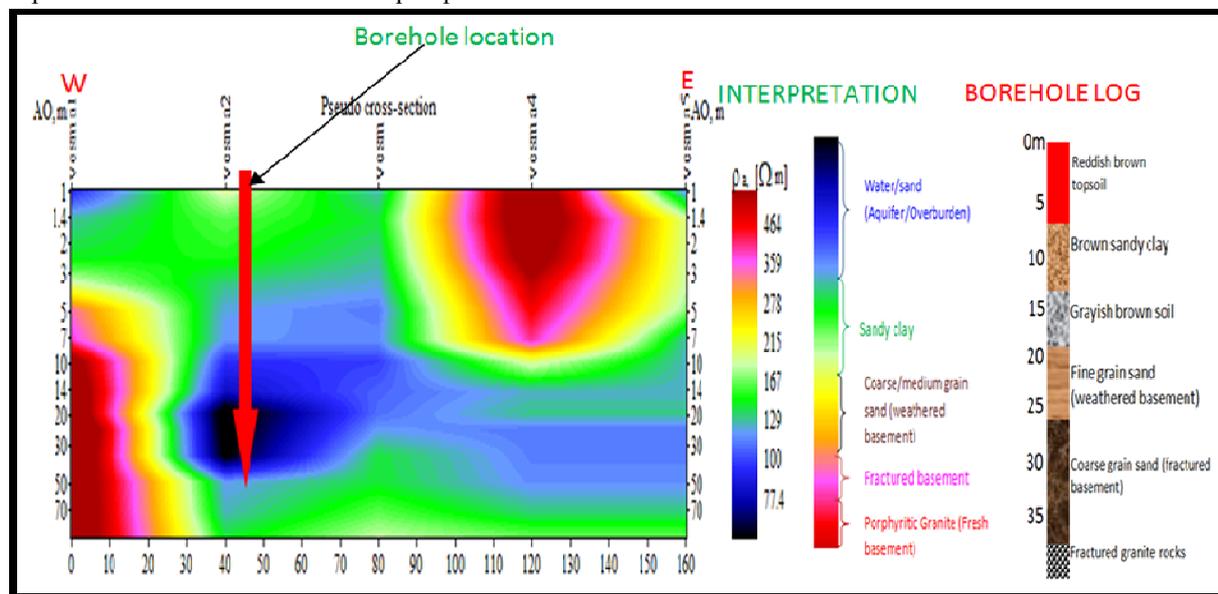
The LGEA Madamai profile is 160m long in the W-E direction. The borehole is non-functional. It is located at latitude  $09^{\circ}40'23.58''N$  and longitude  $08^{\circ}24'11.80''E$ . five (5) VES Points were sounded along the profile at 40m interval. The calculated apparent resistivities at all the VES points along the profile were inverted to produce an image using IPI2win+IP software. The image (figure9) shows that there is a high resistivity anomaly at VESma4

which may be as a result of protrusion of granites around that point. The layers underlain the boreholes around VESma2 composed of water and sandy soil which is a good and promising aquiferous layer. The borehole was drilled to a depth of 48m, the recorded initial yield was 11.5litre/min, and the static water level was 10m (KSWB, 2006). The plausible causes of the borehole failure can be attributed to design, construction, operation and maintenance factors. It is possible for one factor to lead to the other. For example, a borehole poorly constructed and completed could result in clay/silt pumping and eventually affect the rubber seals in the handpumps or the impellers in the case of submersible pumps.

Figure9: Resistivity tomography section for LGEA Madamai Profile
